Deficiencies in the Existing Belknap County Jail and House of Corrections Facility

By Daniel P. Ward Sr.,
Superintendent

March 28, 2013

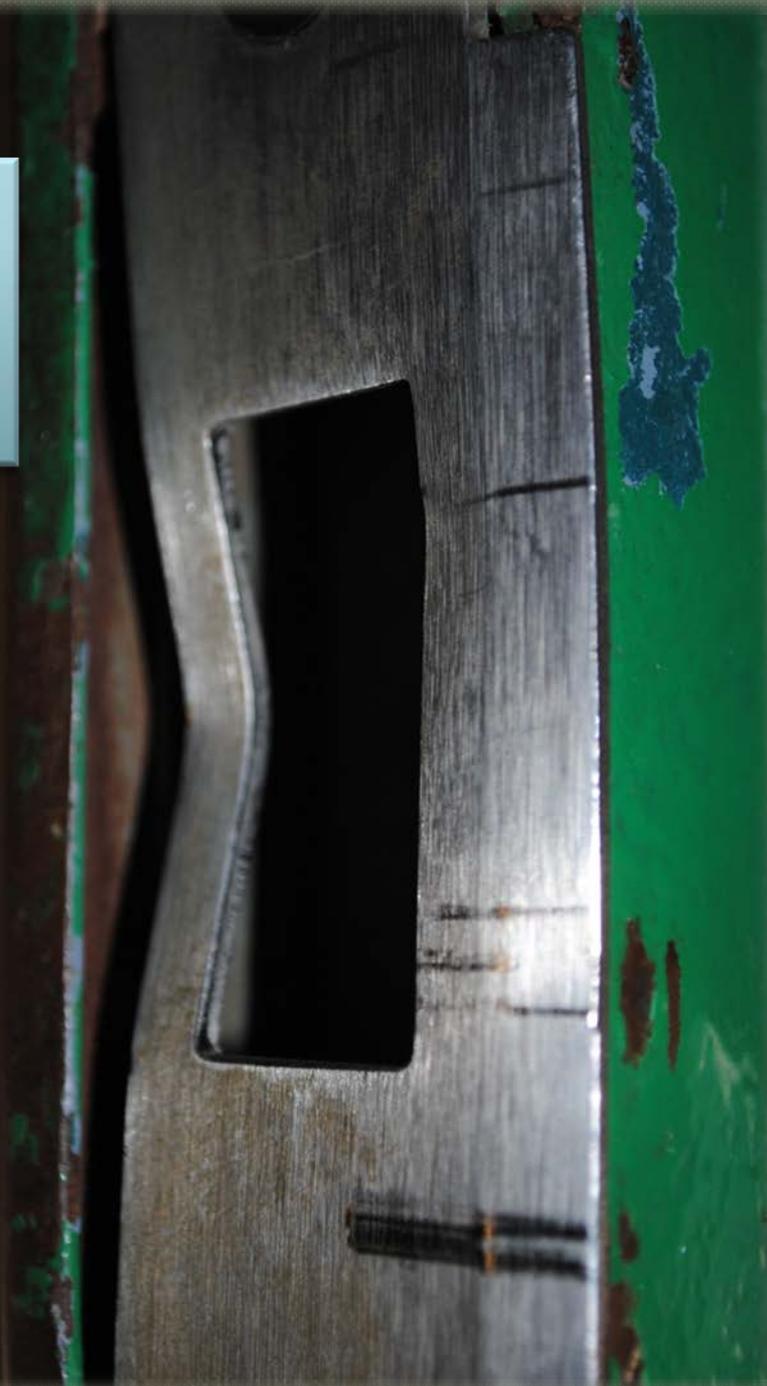
Many door locks have strike plates that are broken, bent, or no longer can receive a lock bolt.

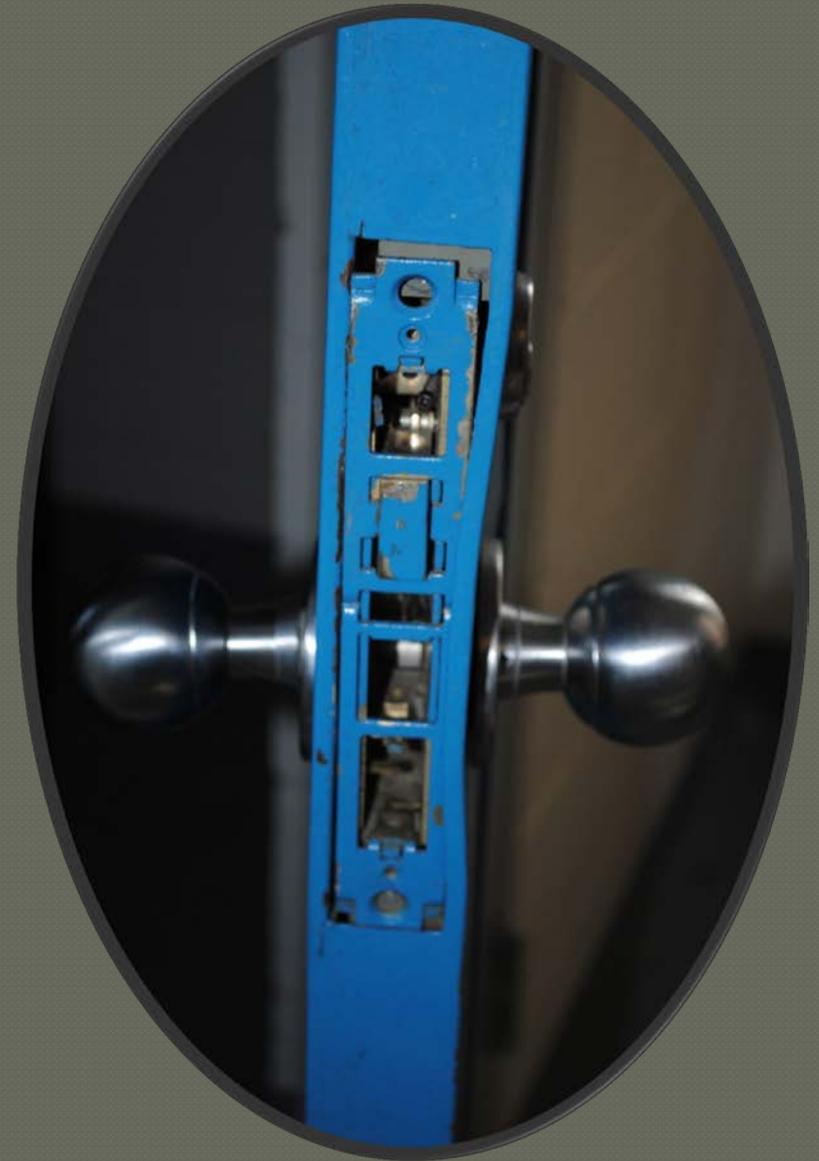
Many of the cell door locks have been destroyed or parts taken to repair others.

Some cells have no lock parts in them at all!

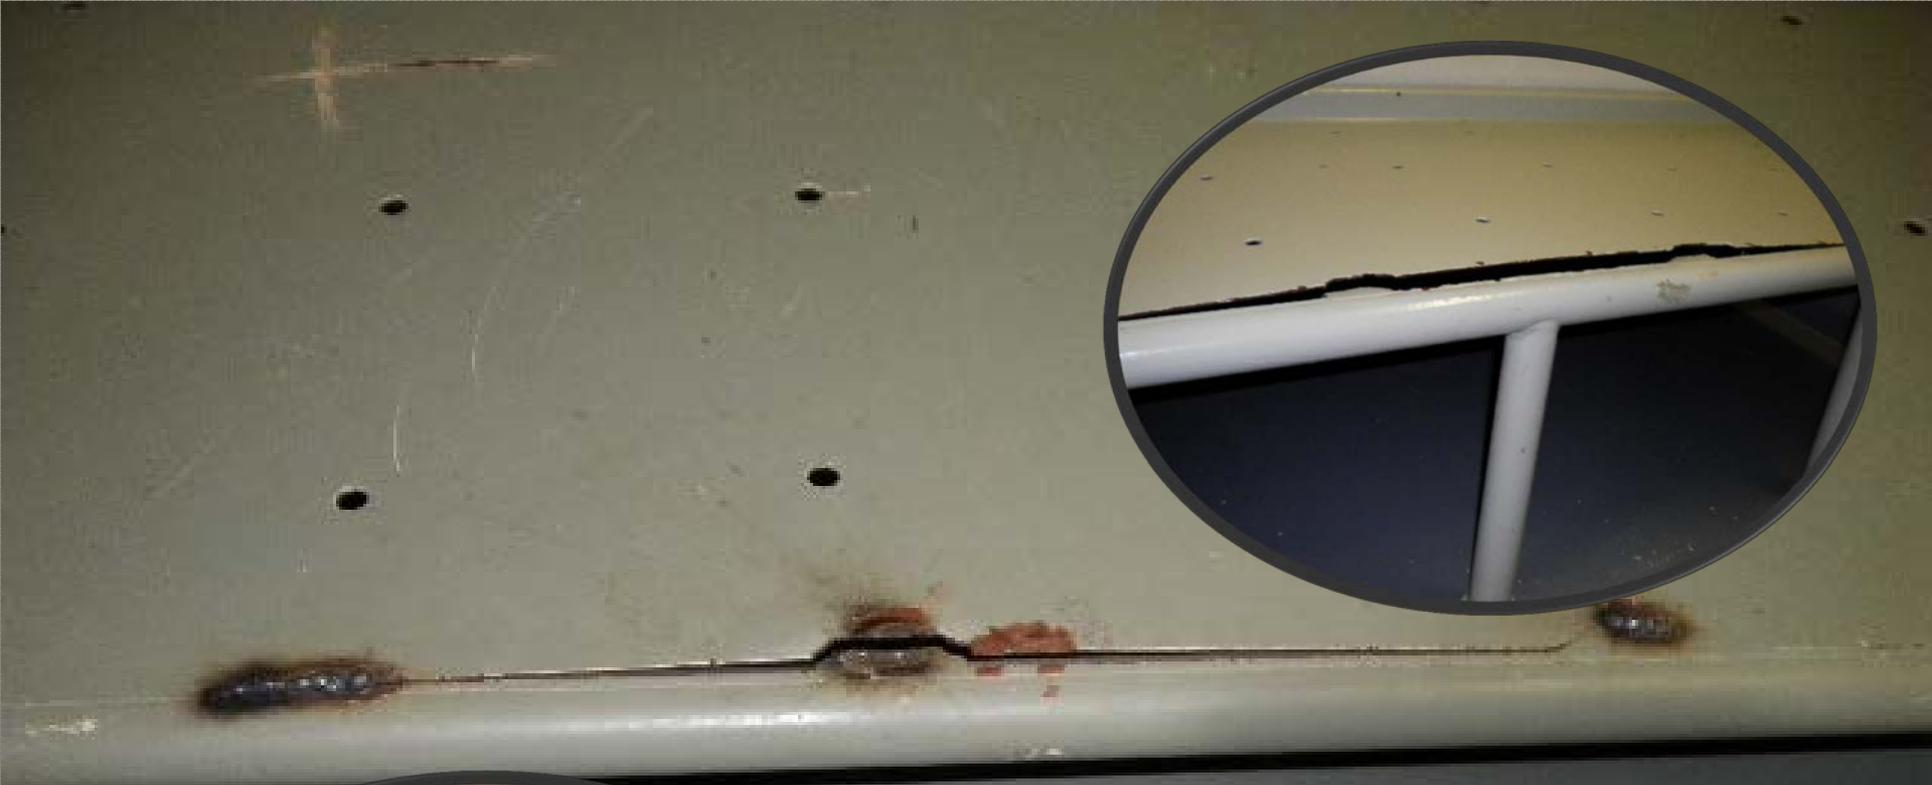
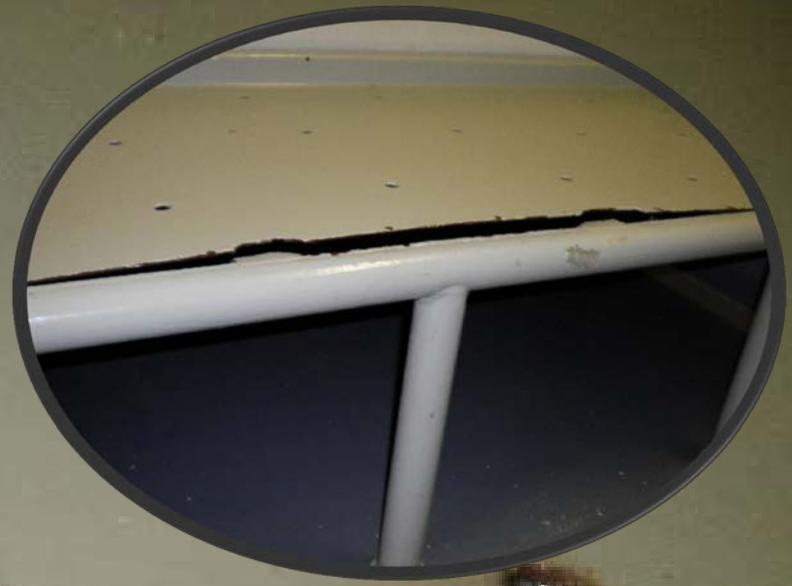
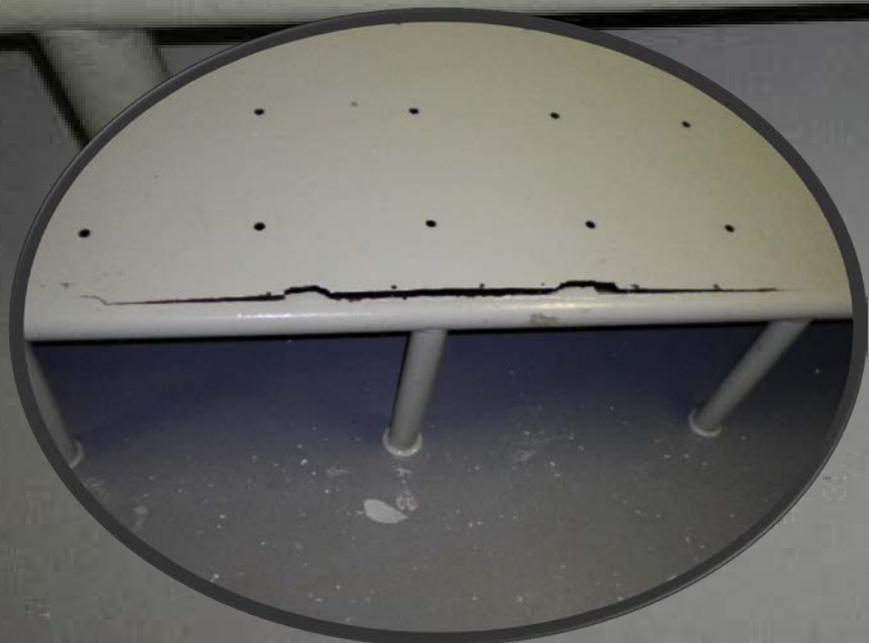
Throughout the facility, the inability to evacuate steam from housing unit showers has resulted in mold and rusting of ceilings, floors, and any metal surface.

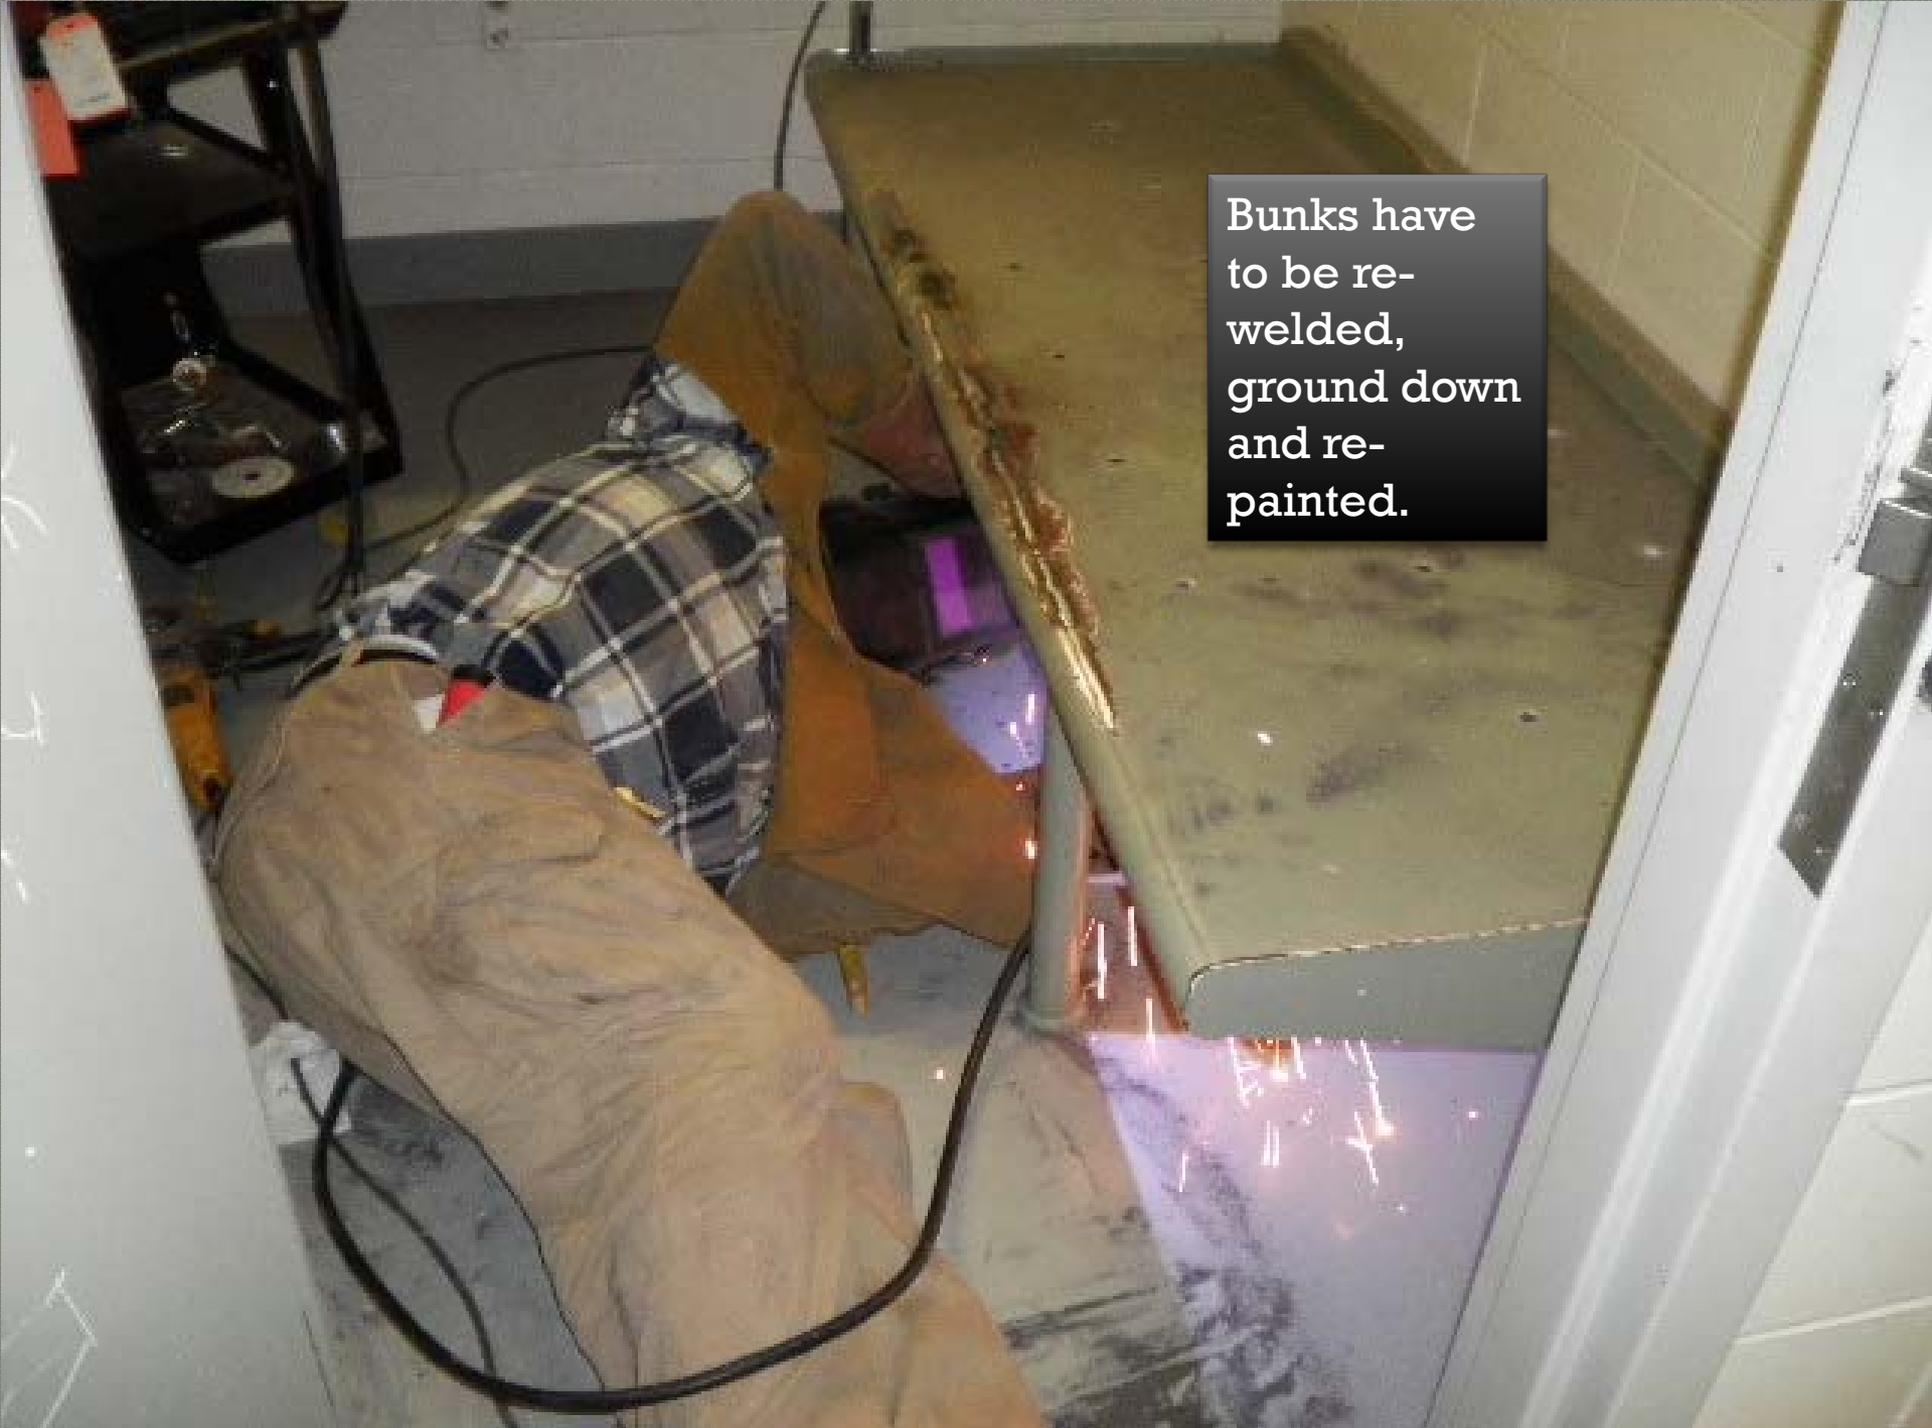
Years of wear has resulted in bunk seams separating. These occur in every housing unit. Spot repairs were unsuccessful.

Bunks have to be re-welded, ground down and re-painted.

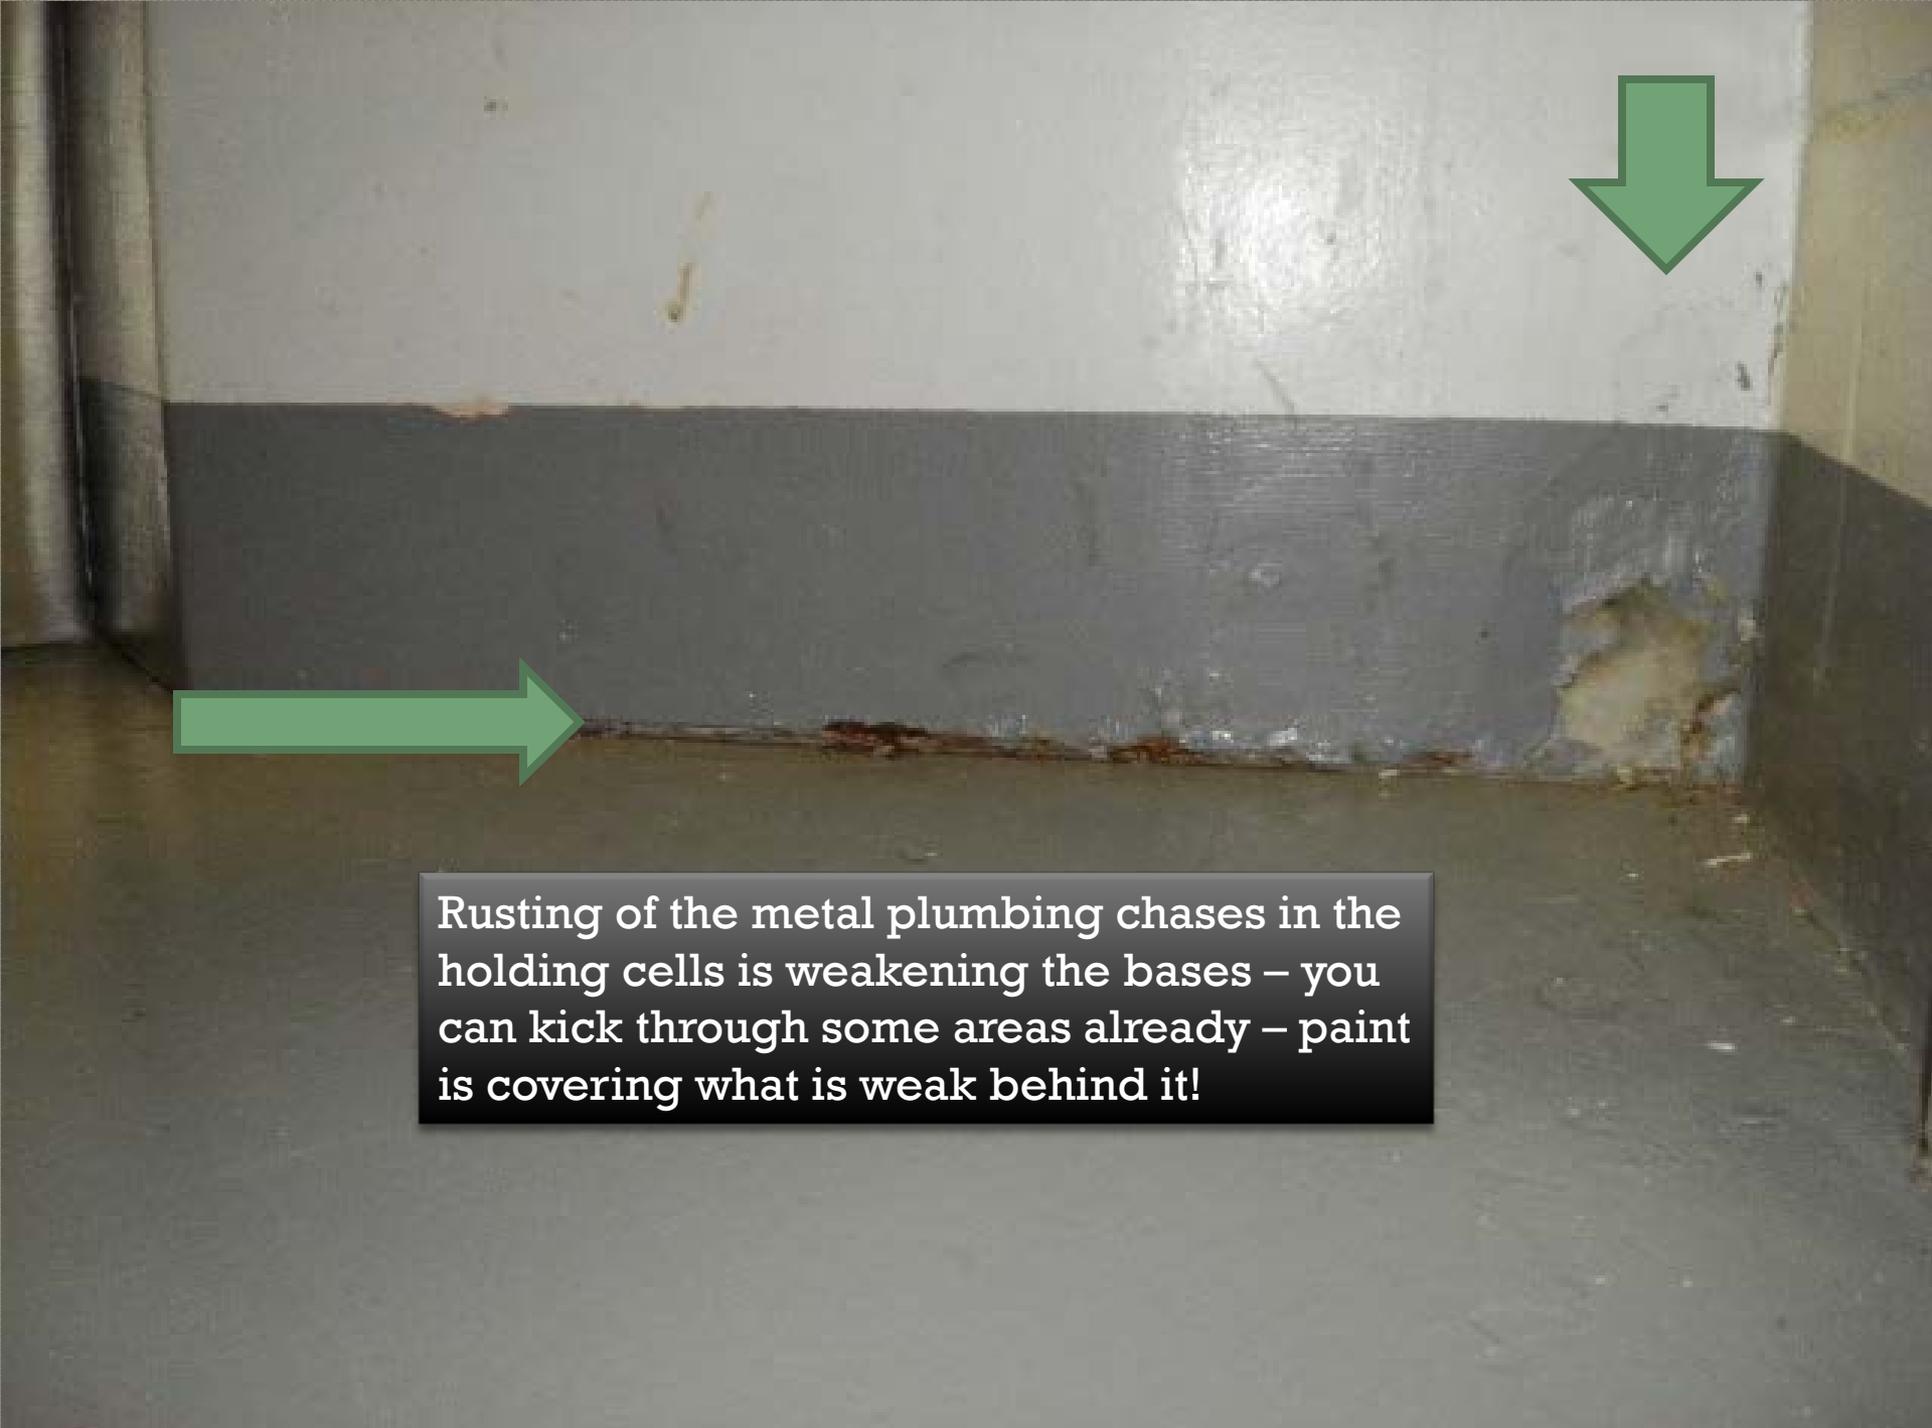
The concrete floor is not sealed, causing paint to simply come off in patches. Metal surfaces closest to the floor are oxidizing against the concrete causing rusting and loss of integrity of the frame.

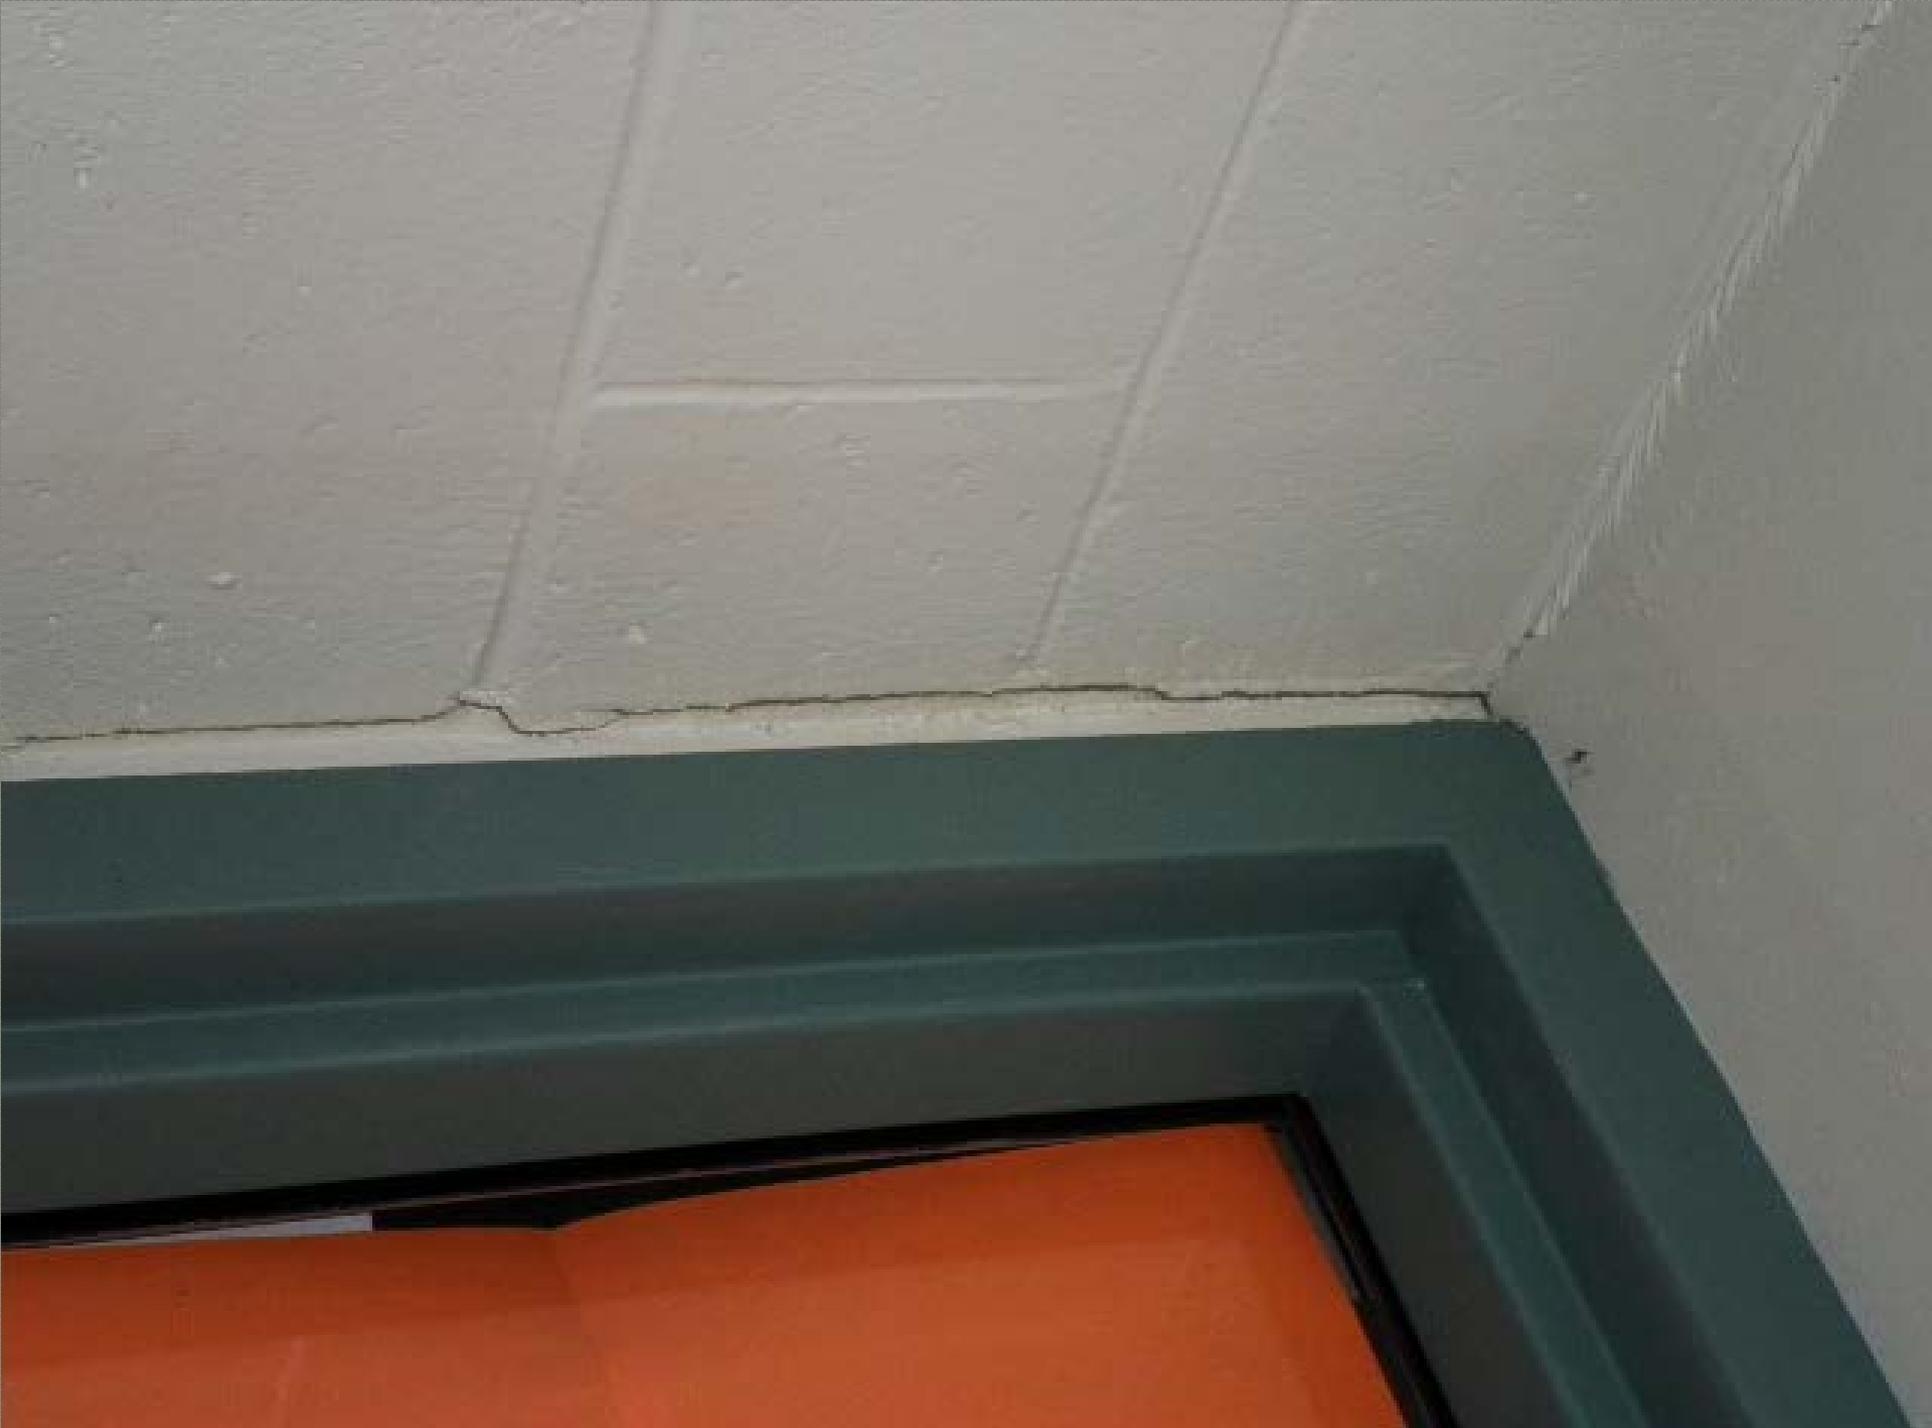
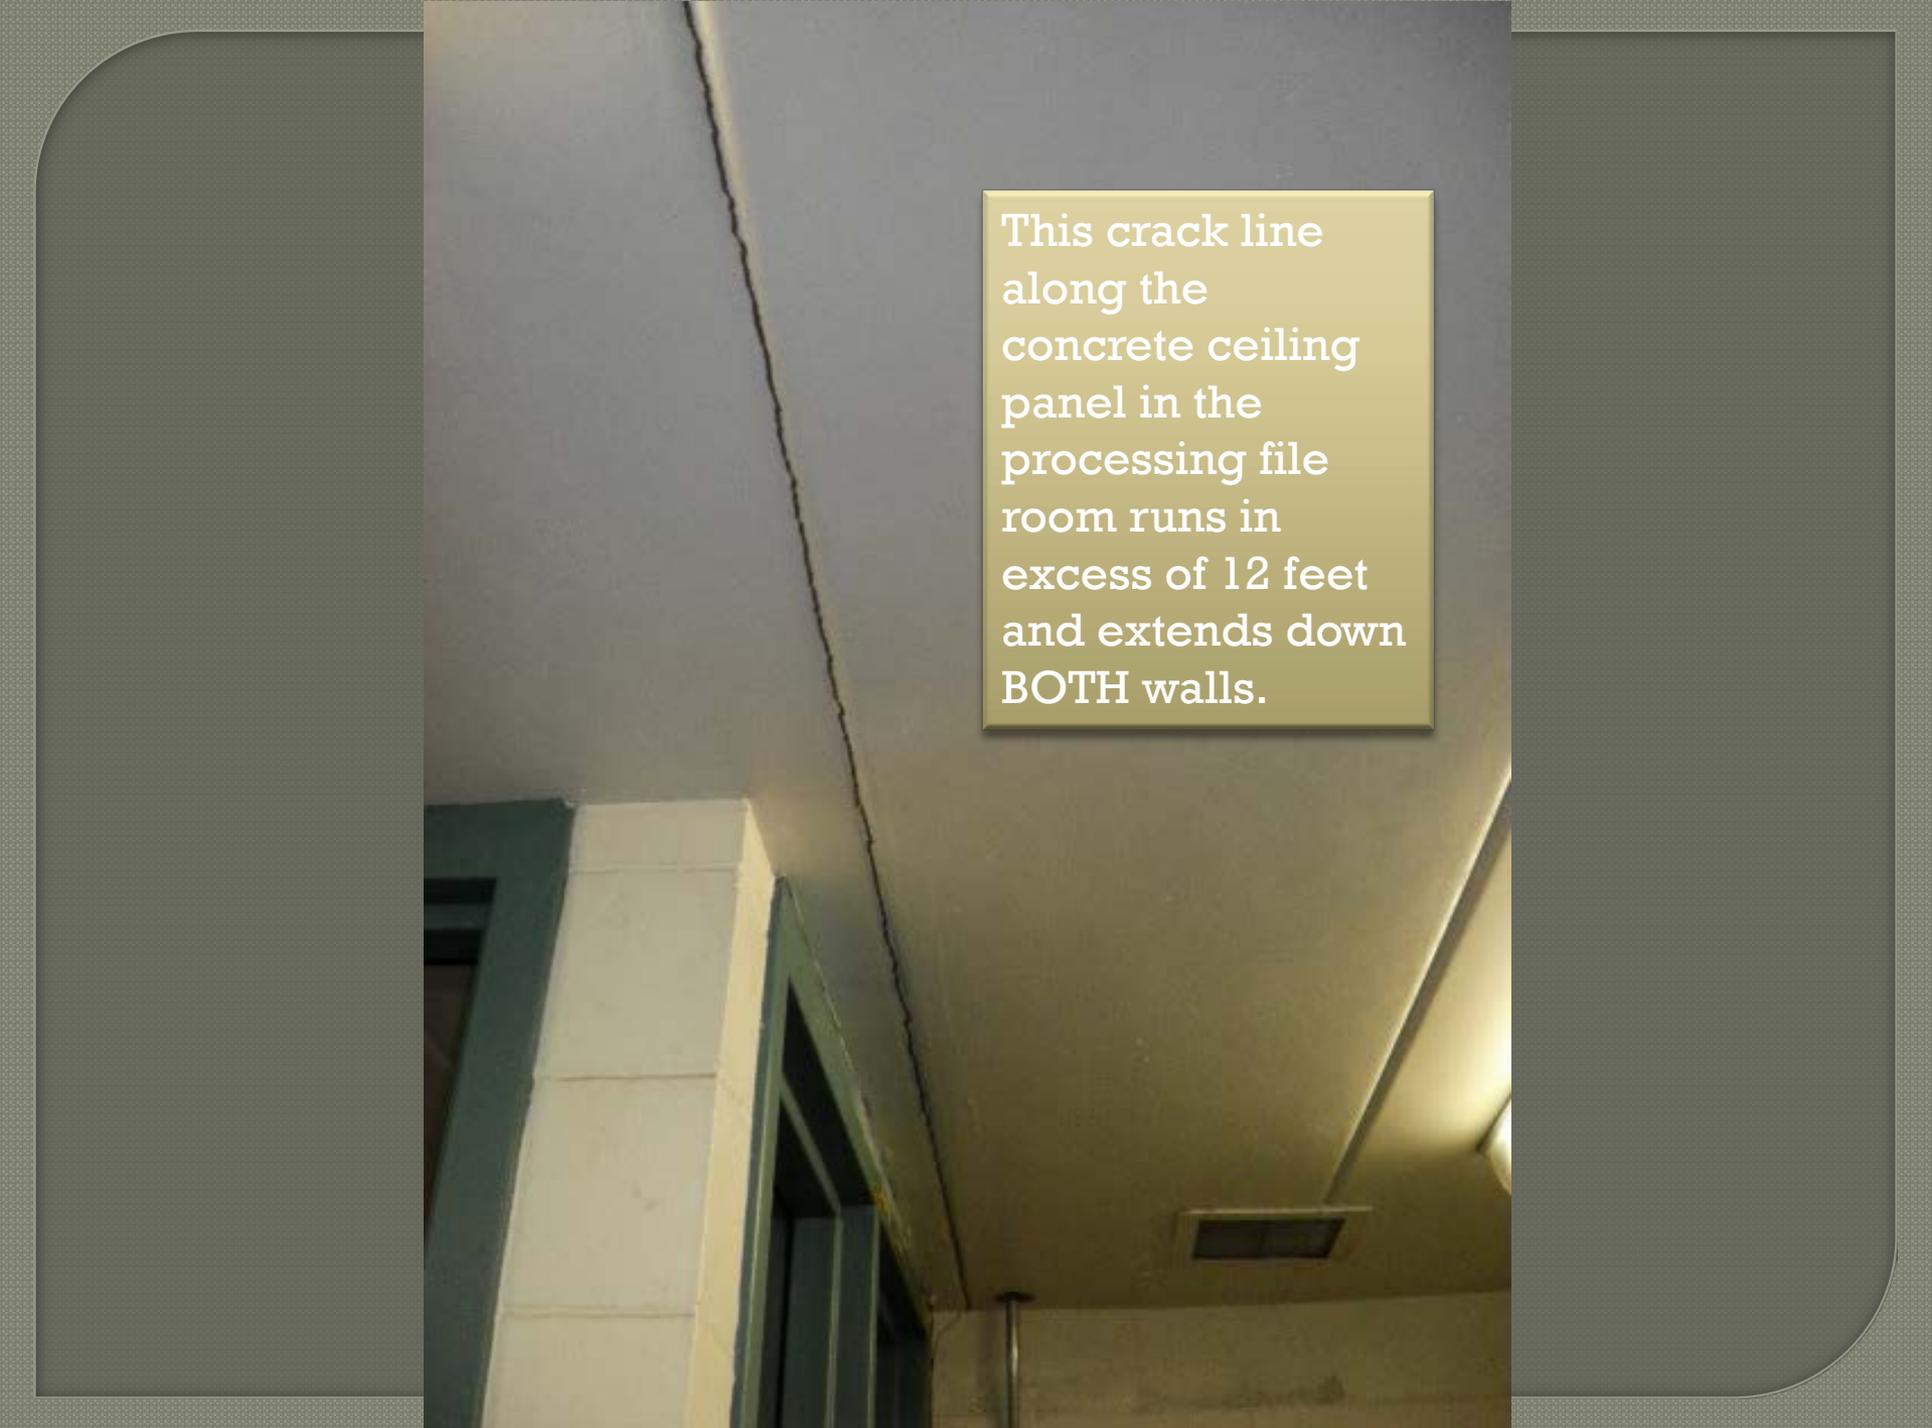
Cracks along the grout lines
(illustrated in this slide and the
next reveal missing grout from
both sides of a block.

In many of these areas where grout is already weakened, the grout can be removed and the whole block can be moved, and contraband hidden – Toothpaste covers the hidden items and appears to be “normal”!

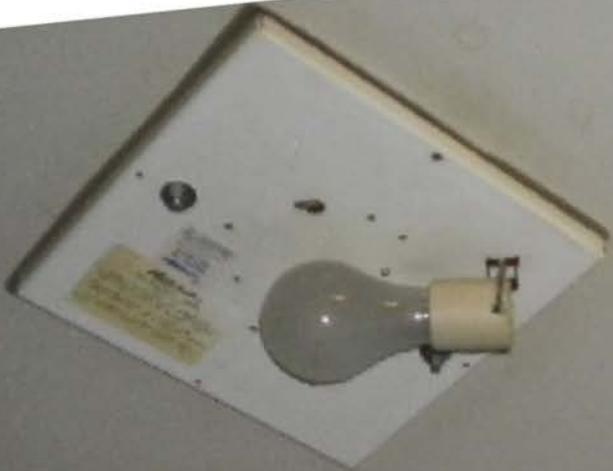
Missing lighting
fixture covers –
covers no longer
made for old
lighting.

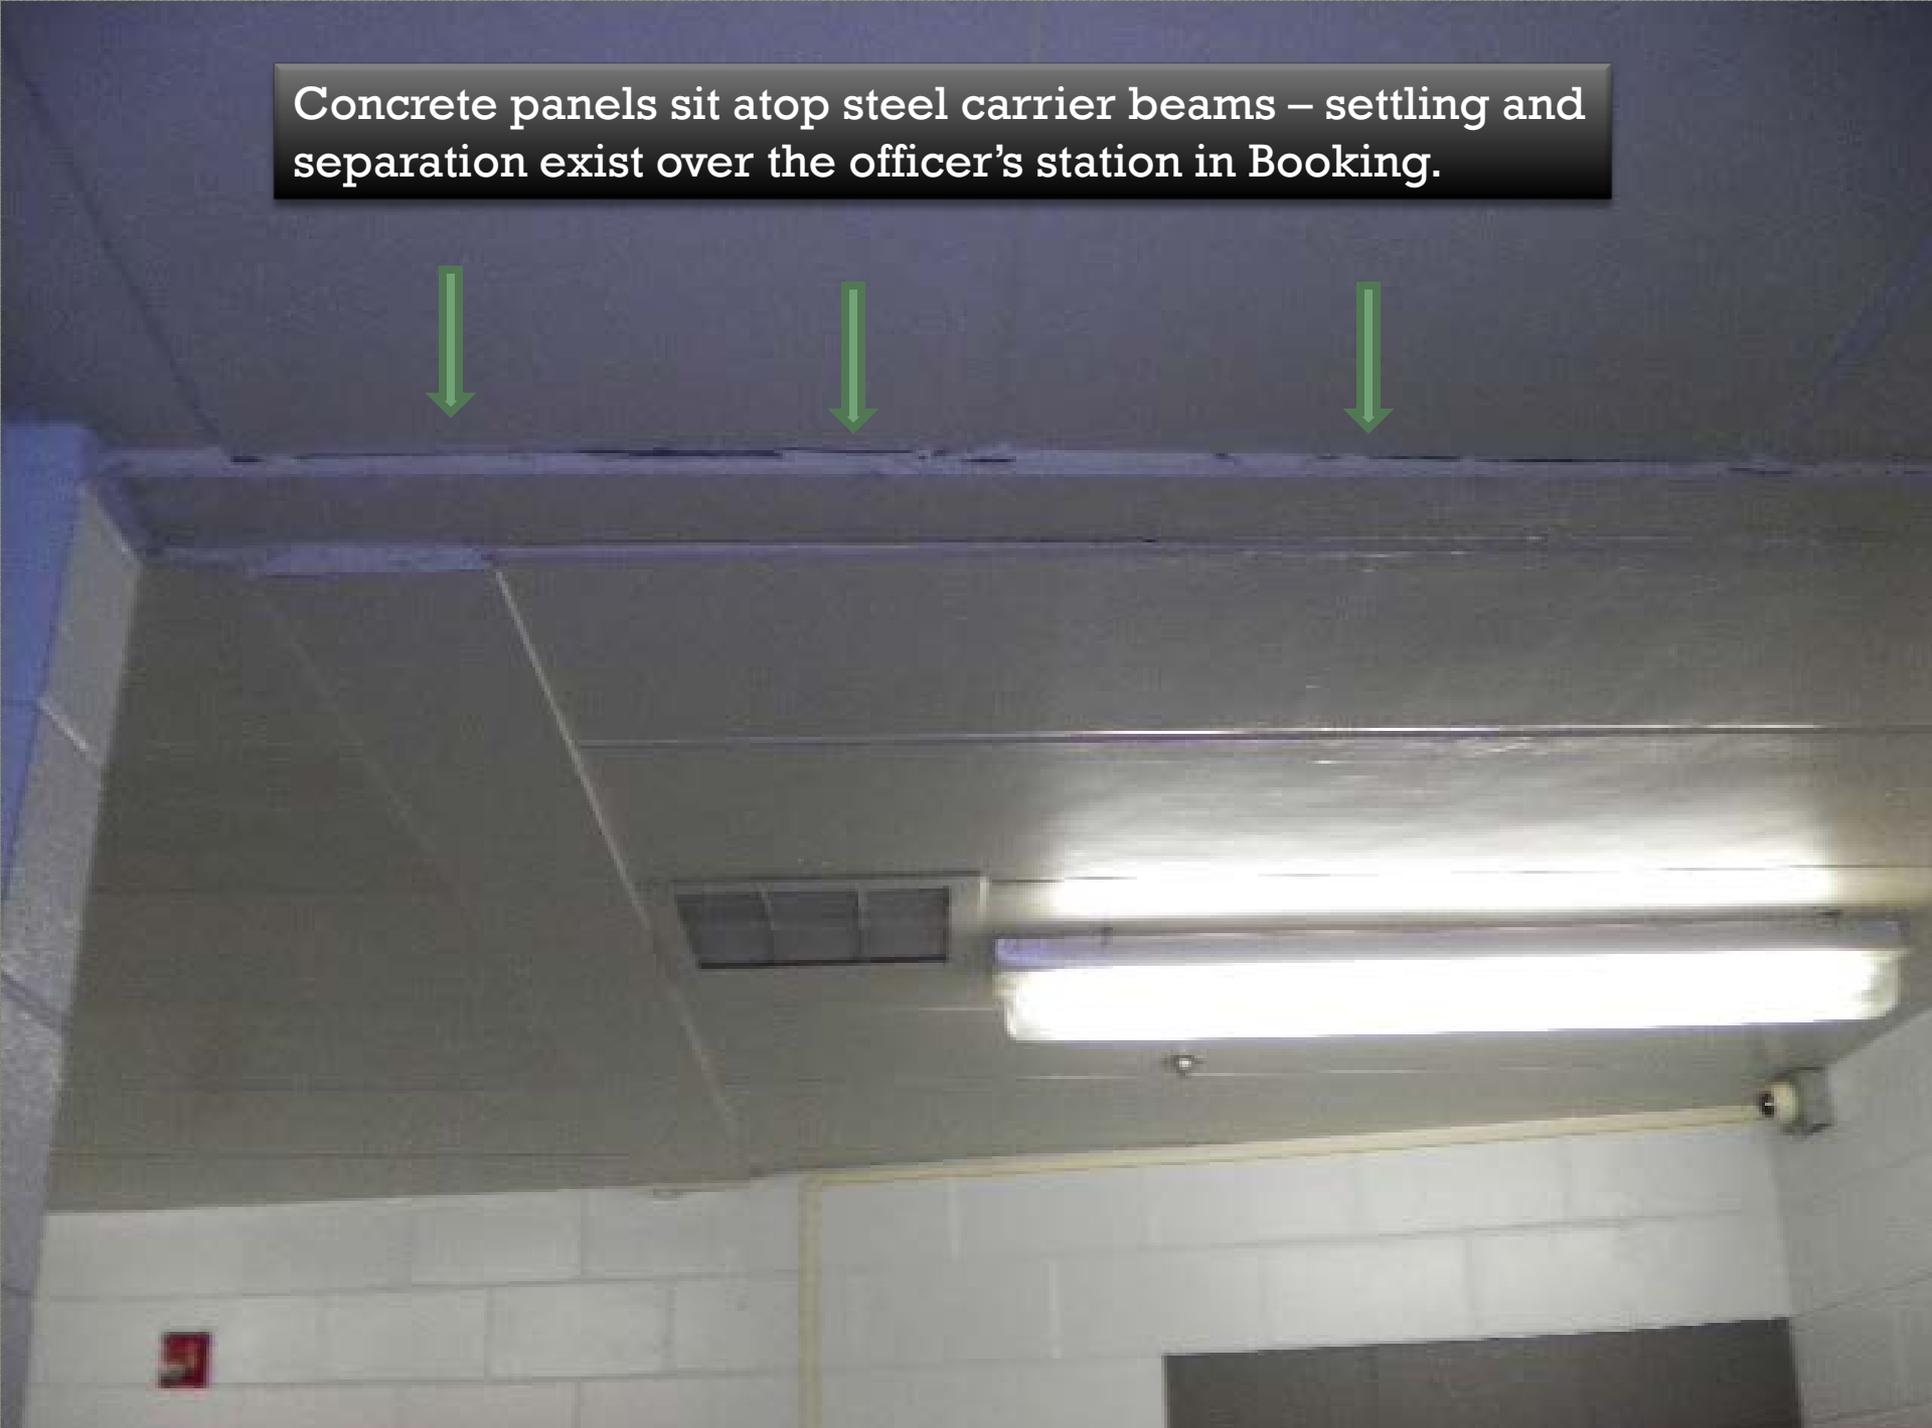
Concrete panels sit atop steel carrier beams – settling and separation exist over the officer's station in Booking.

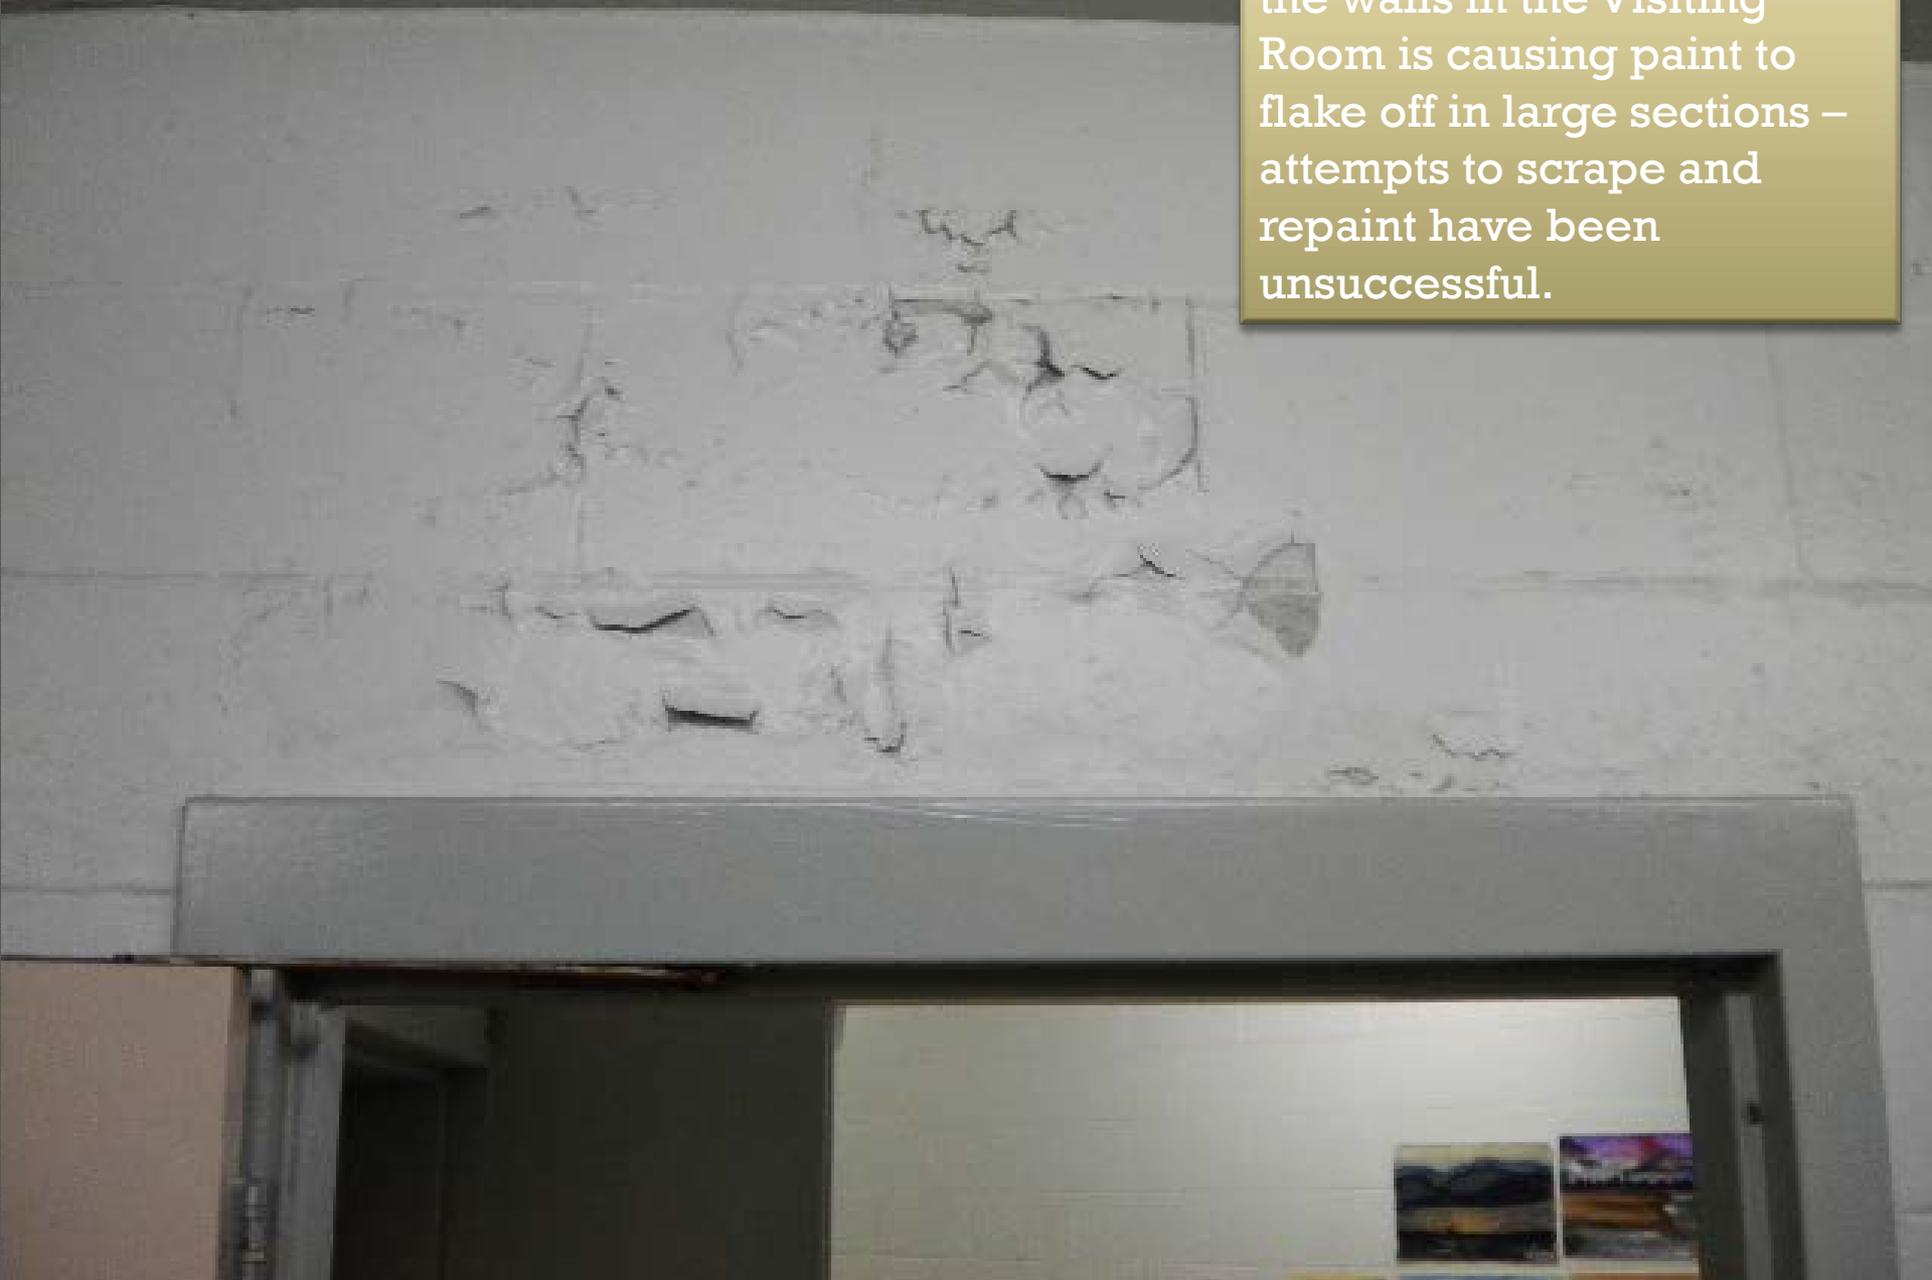
Unknown moisture within the walls in the Visiting Room is causing paint to flake off in large sections – attempts to scrape and repaint have been unsuccessful.

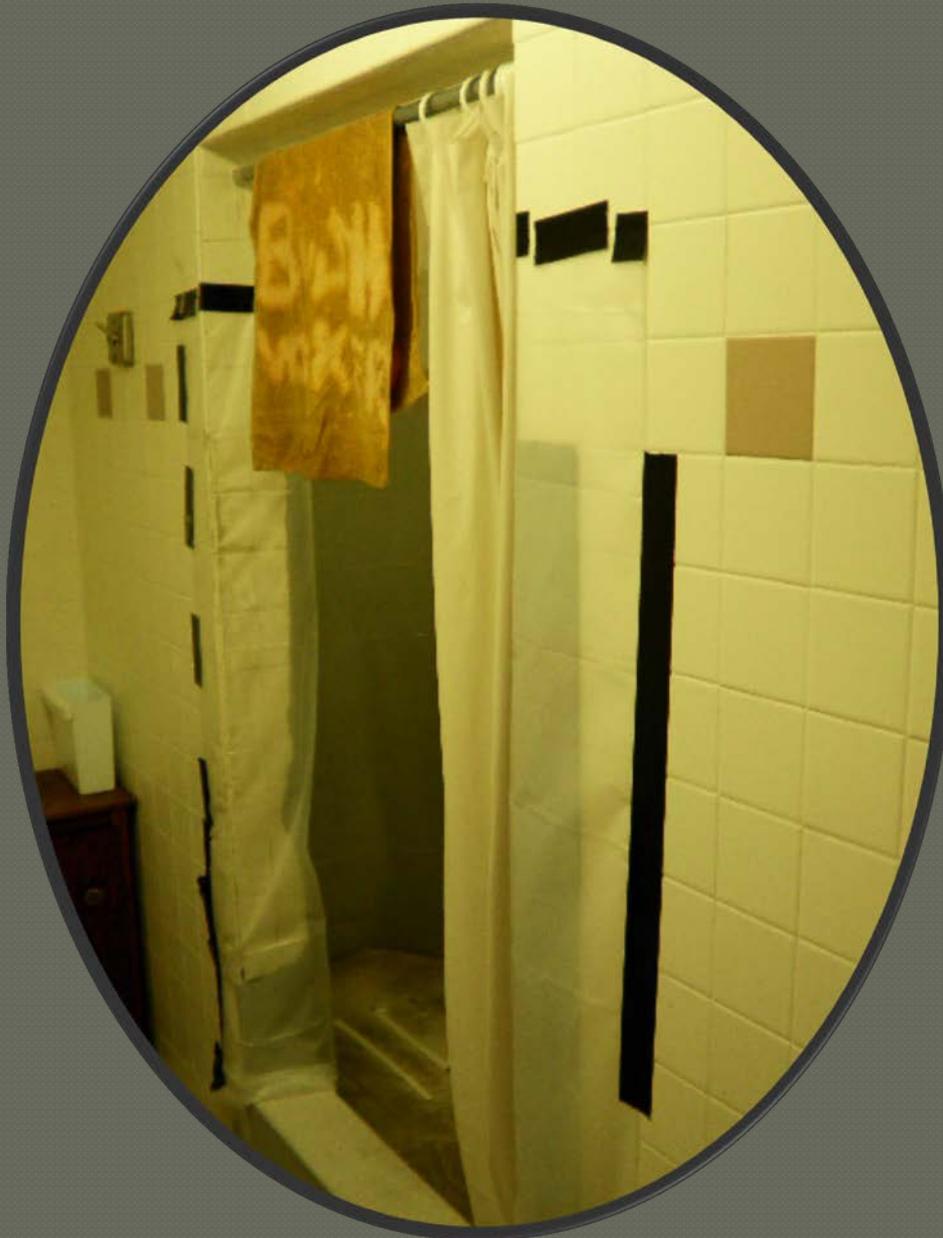
Clear plastic sheets taped to the wall with Duct Tape to prevent water from the showers running in to the wall and through the floors to the housing unit below.
