Deficiencies in the Existing Belknap County Jail and House of Corrections Facility

By Daniel P. Ward Sr.,
Superintendent

March 28, 2013

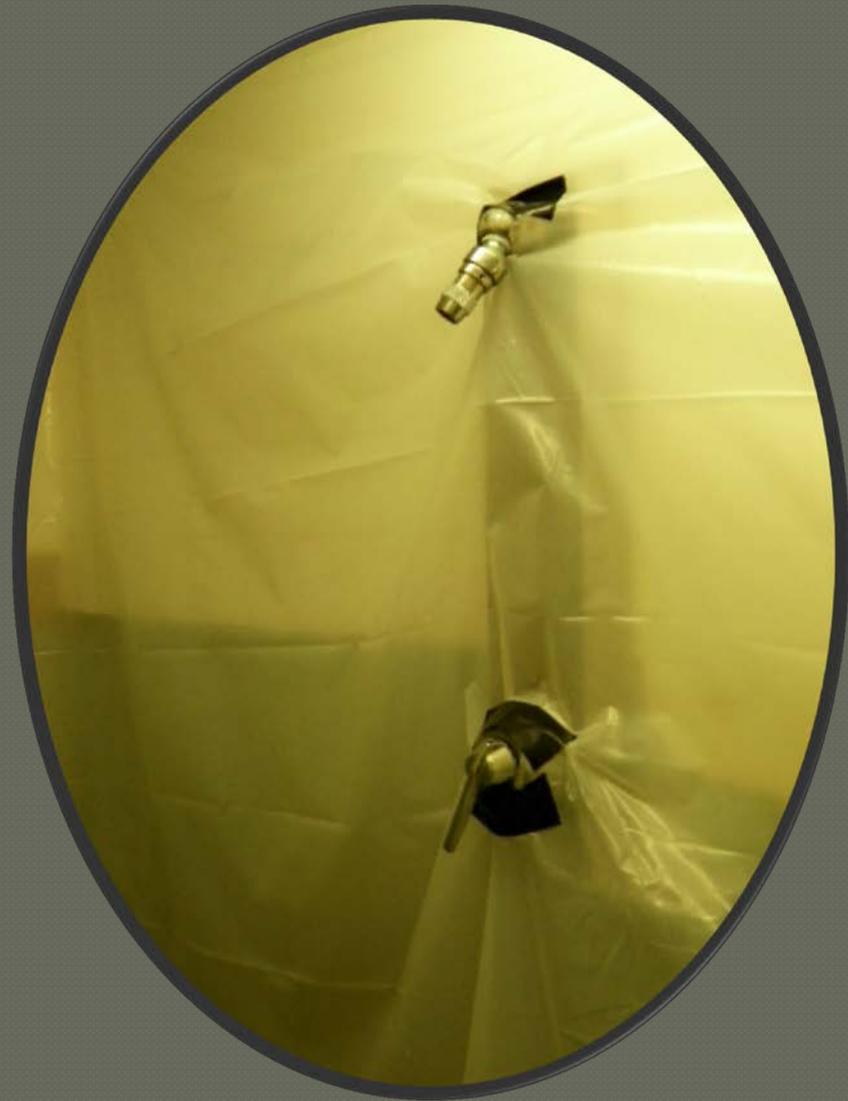
The inside of the women's shower. (16 women share this space) – cannot be cleaned or sanitized.

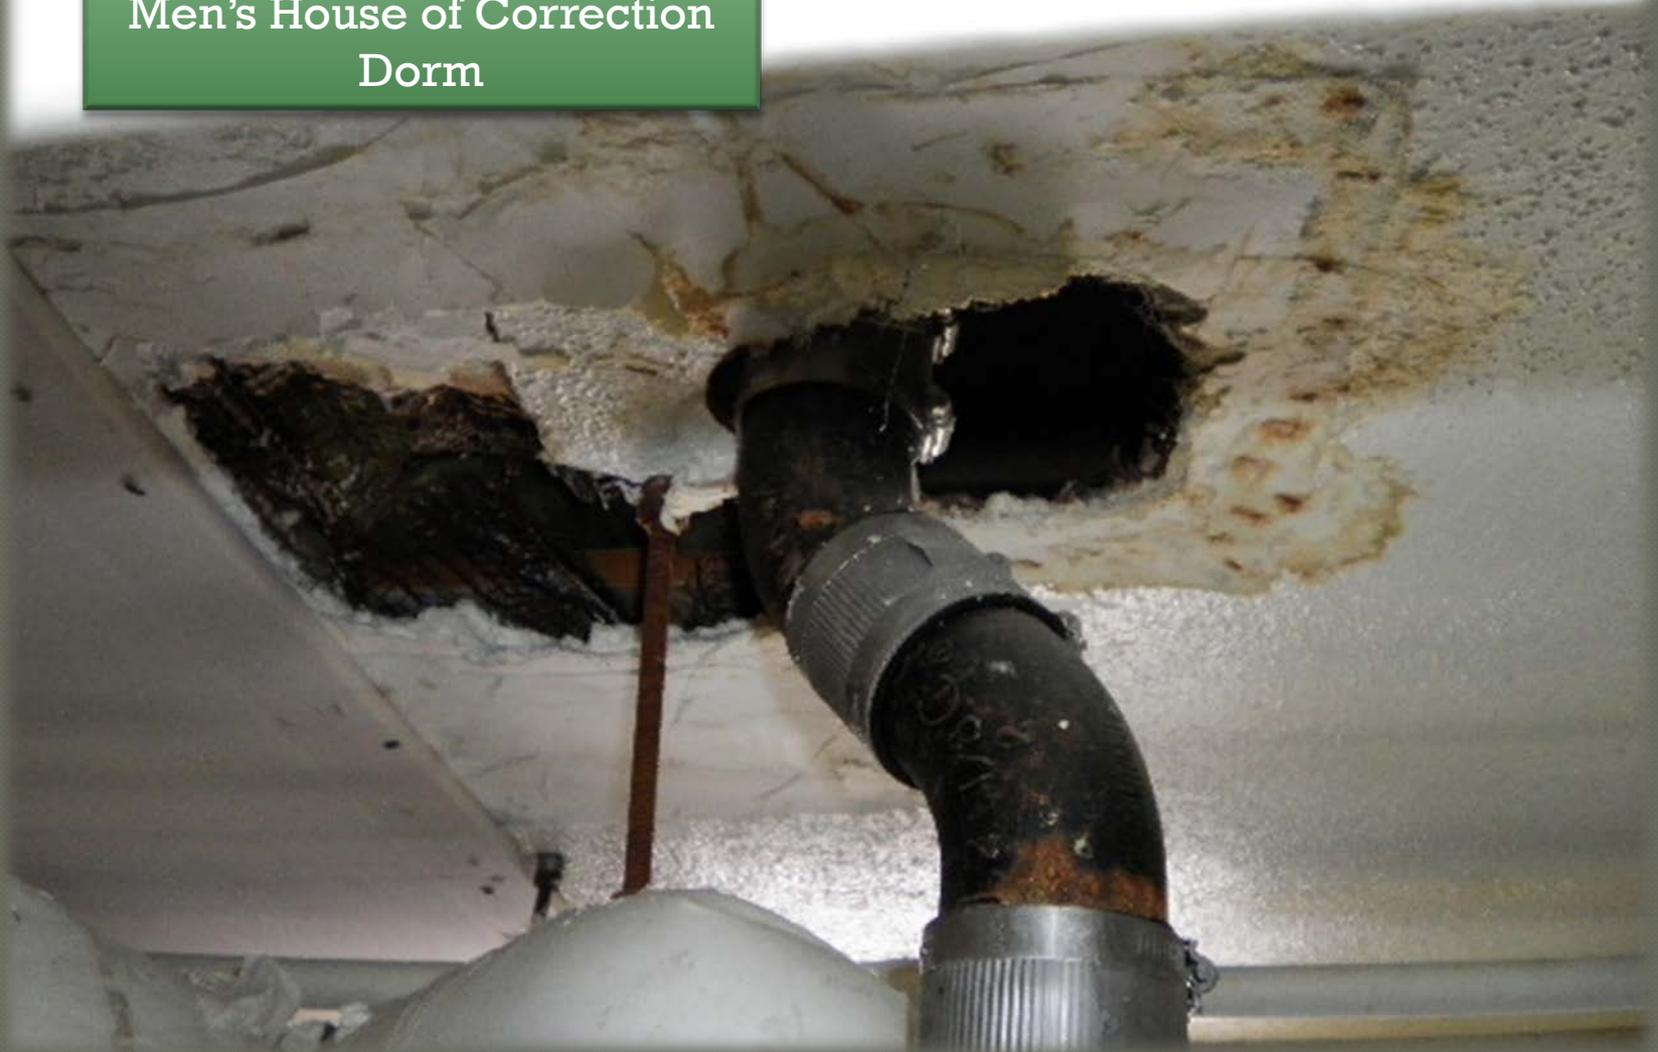
MOLD and leaking from
Women's Shower in to the
Men's House of Correction
Dorm

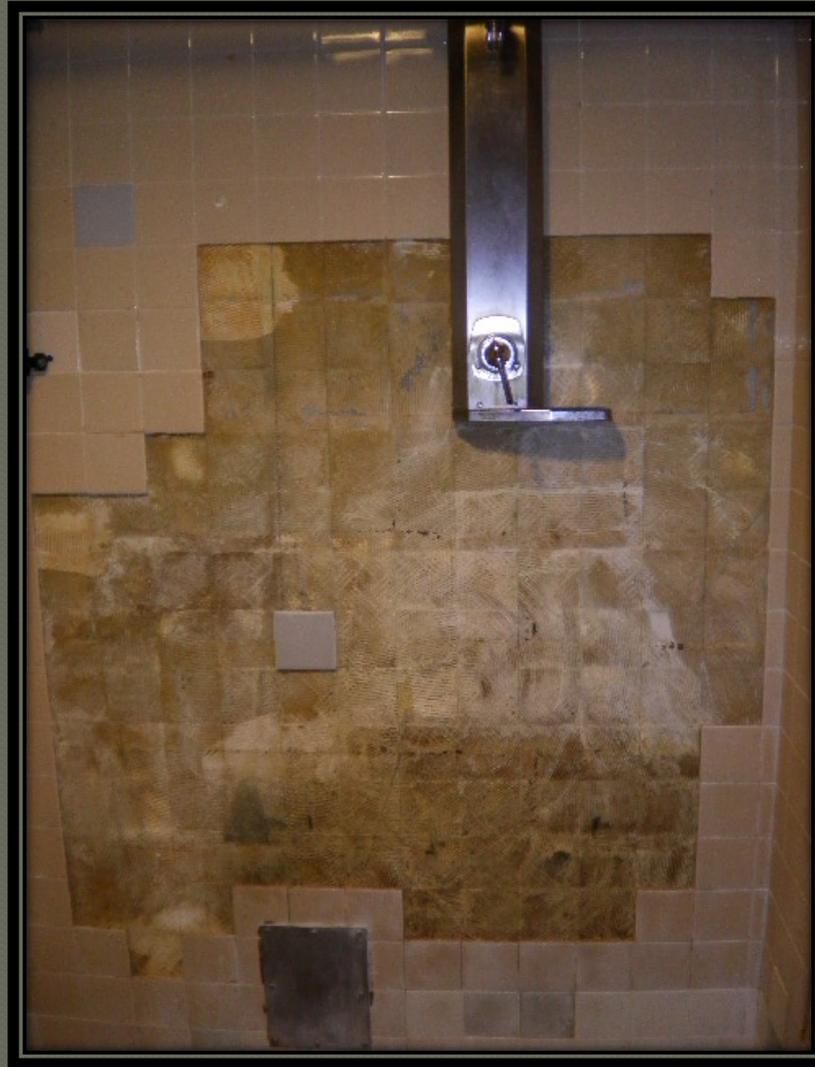
Men Shower
in the
House of
Corrections

Tiles are
dropping off
the wall – only
two of the four
heads work
(for 32 men)

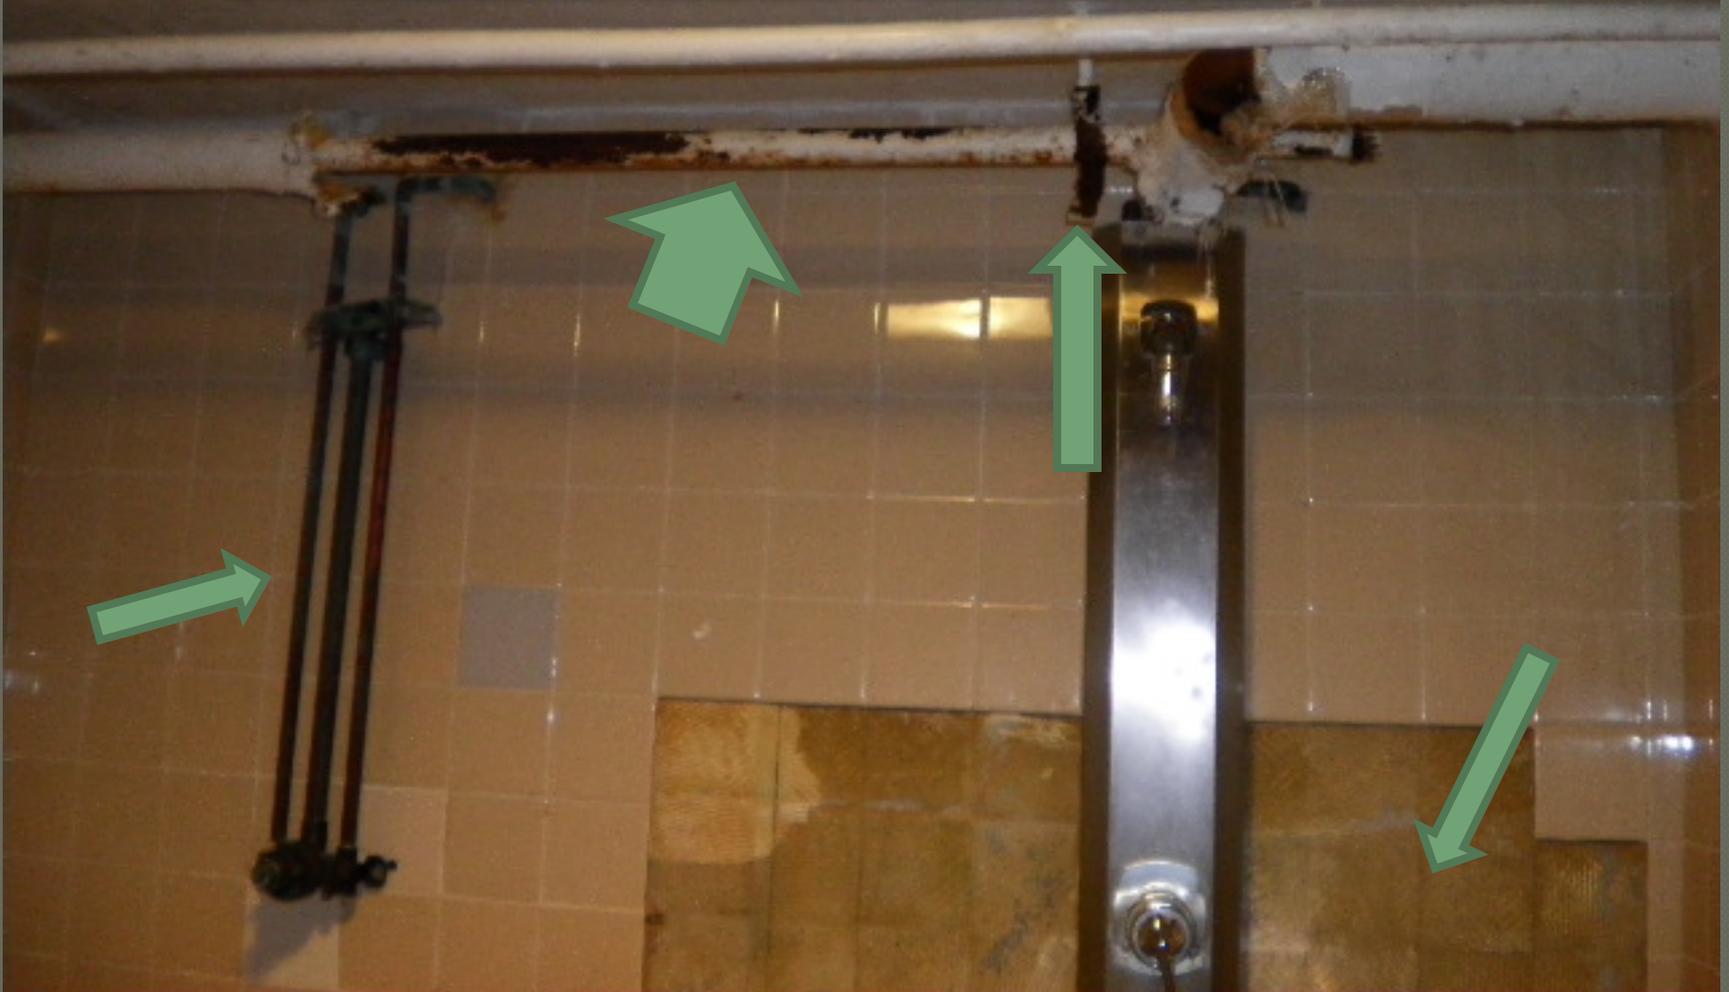
Rusted pipes, missing insulation, broken hanger brackets and missing shower components rounds off the House of Correction shower deficiencies.

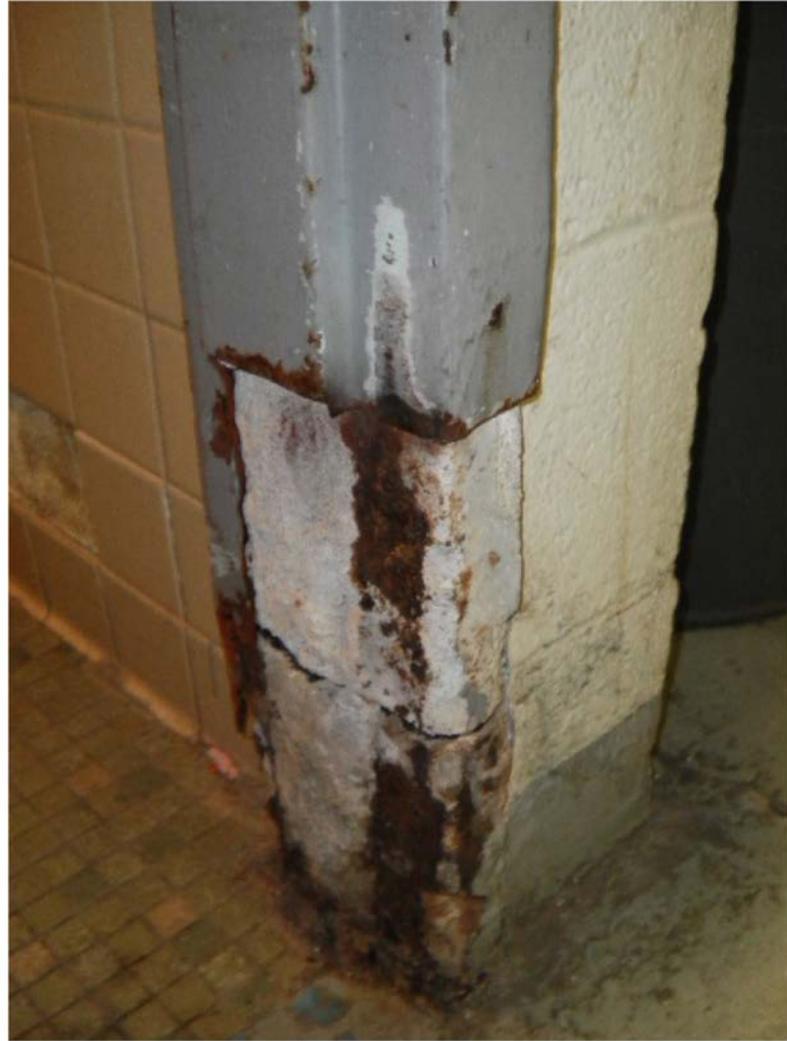
As the metal door frames rust away, each is cut away to prevent jagged edges and the ability to turn pieces of the metal into weapons.

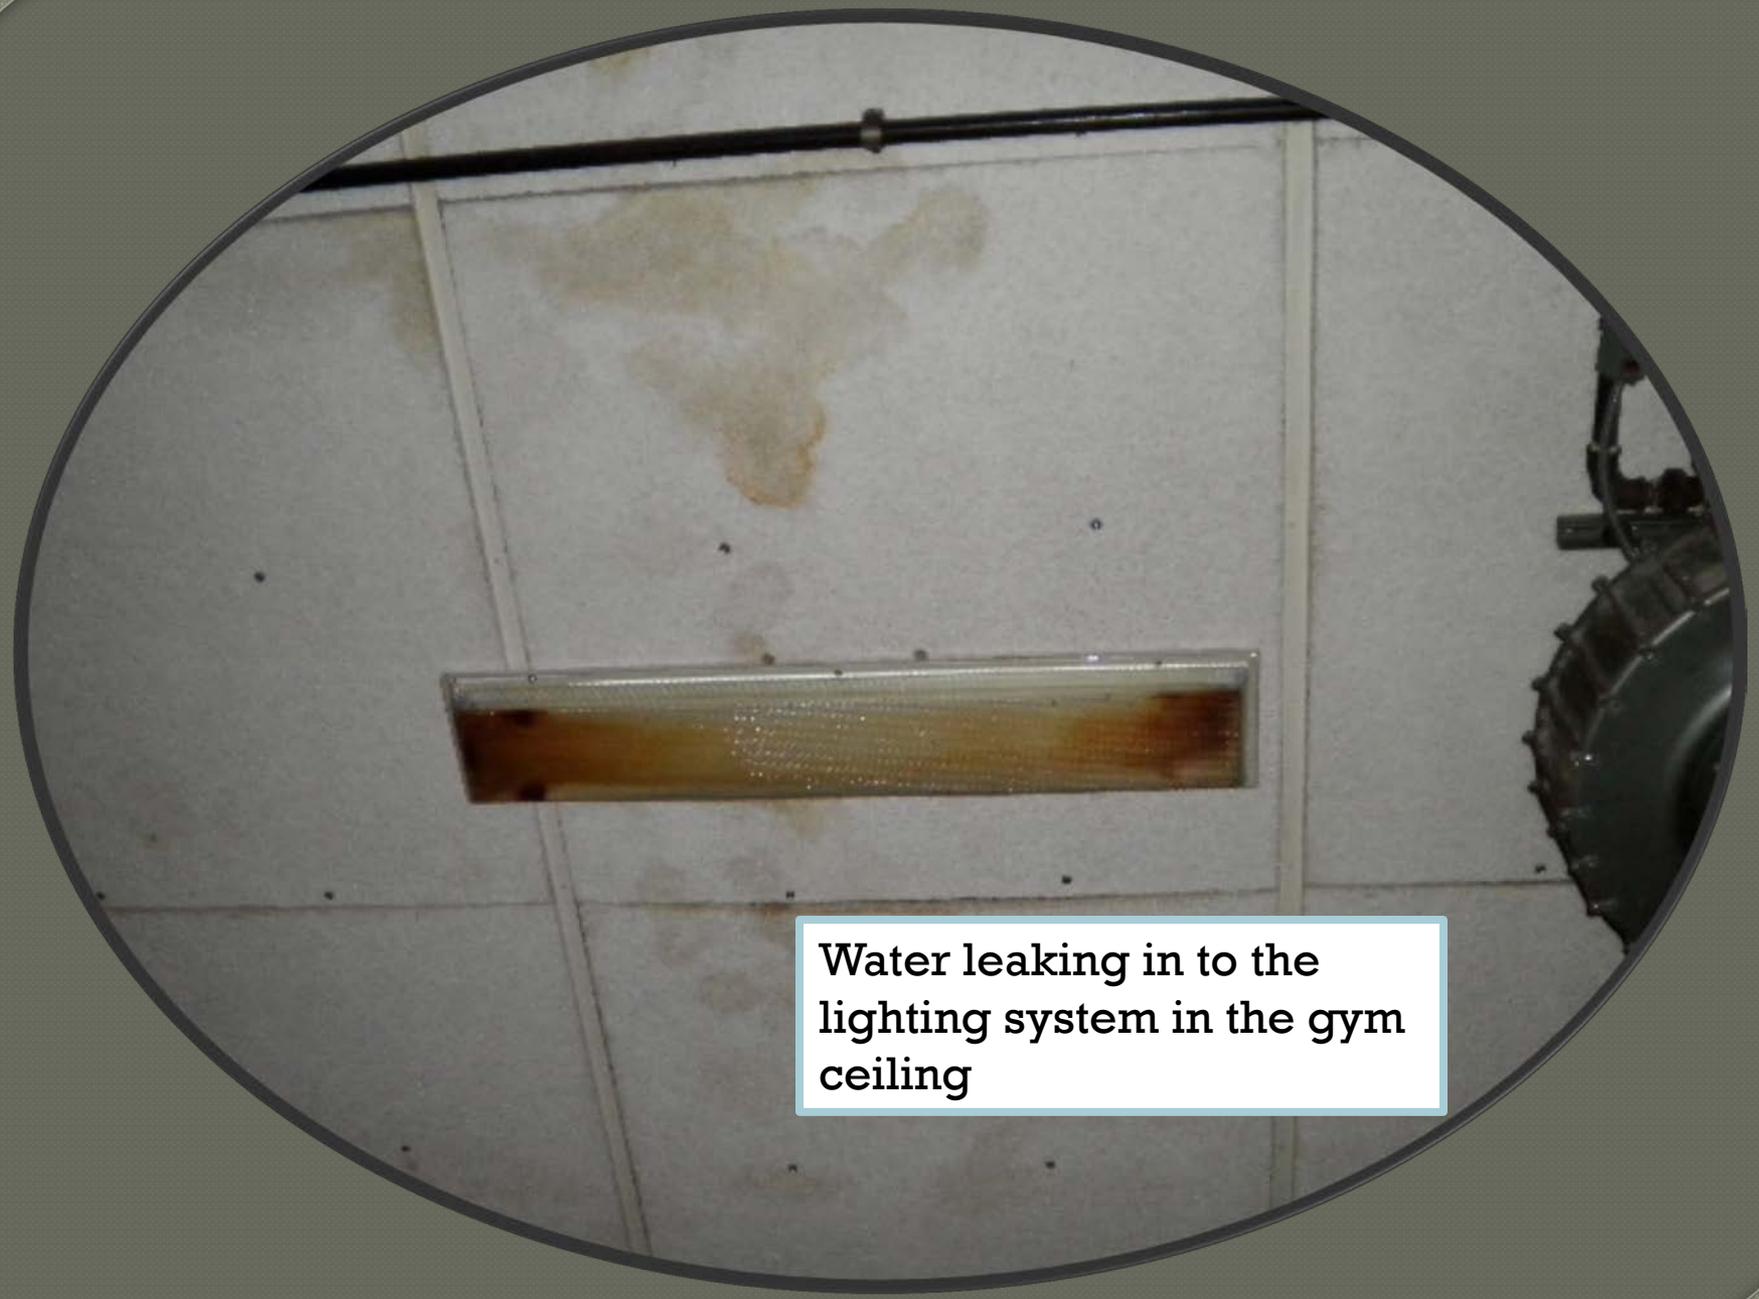
Its
RAINING
again

Trash barrels
placed in the
gym to collect
rain water
from the
ceiling
(cuppola)

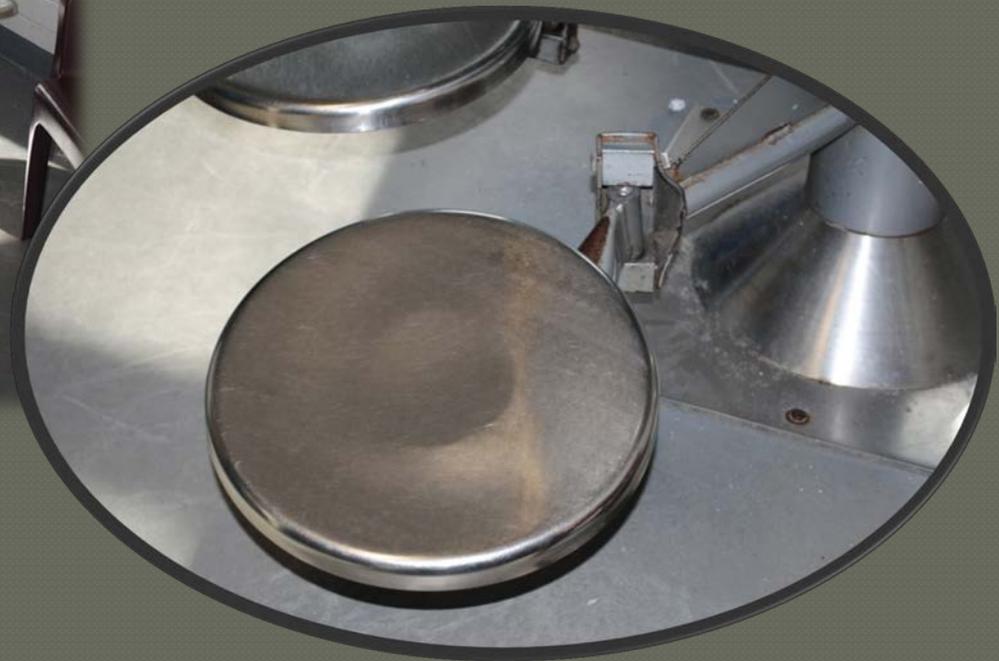
Stainless steel seats in J-7
and J-12 are bent and no
longer hold inmates'
weight

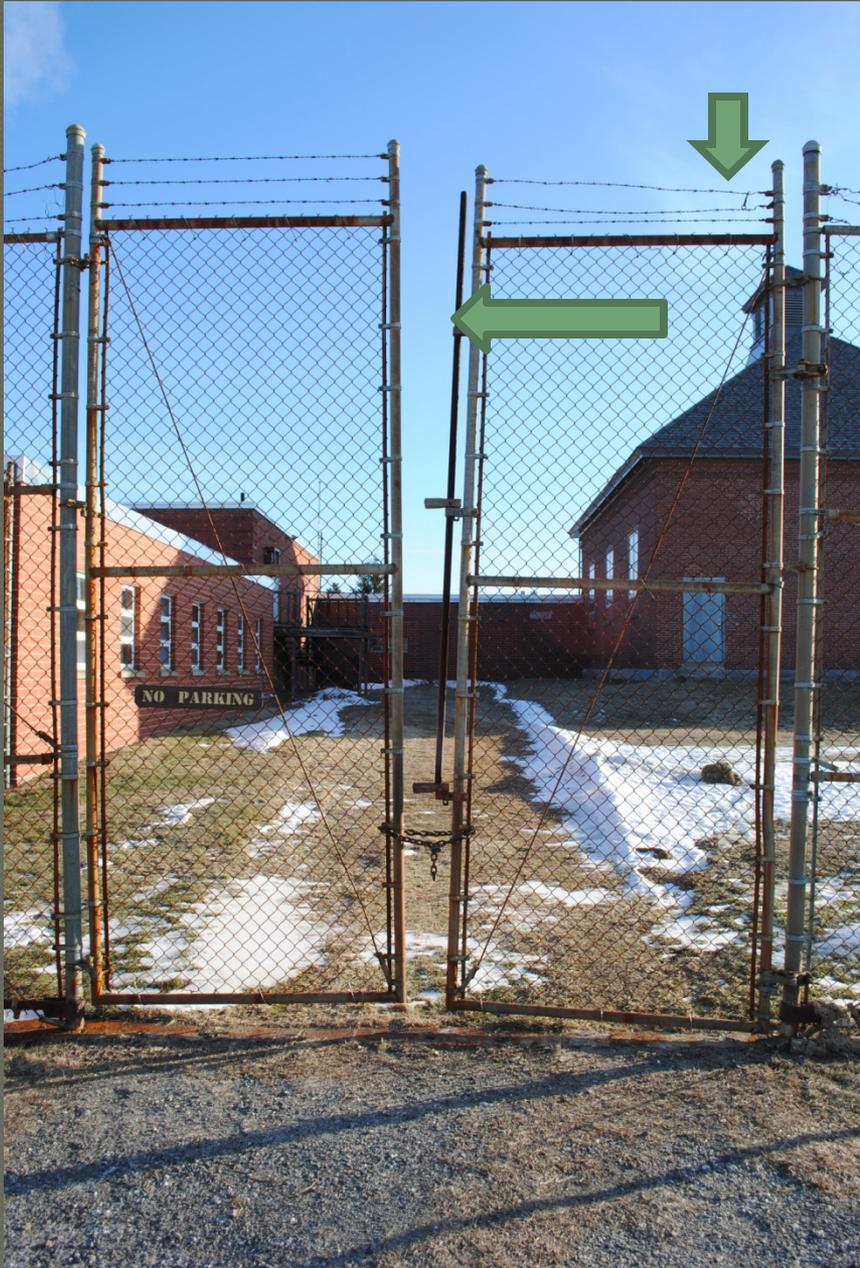
Doors to the basement / vault have rusted and can be pulled open – exterior fence has been padlocked to prevent access to this “inner door”
