Deficiencies in the Existing Belknap County Jail and House of Corrections Facility

By Daniel P. Ward Sr.,
Superintendent

March 28, 2013

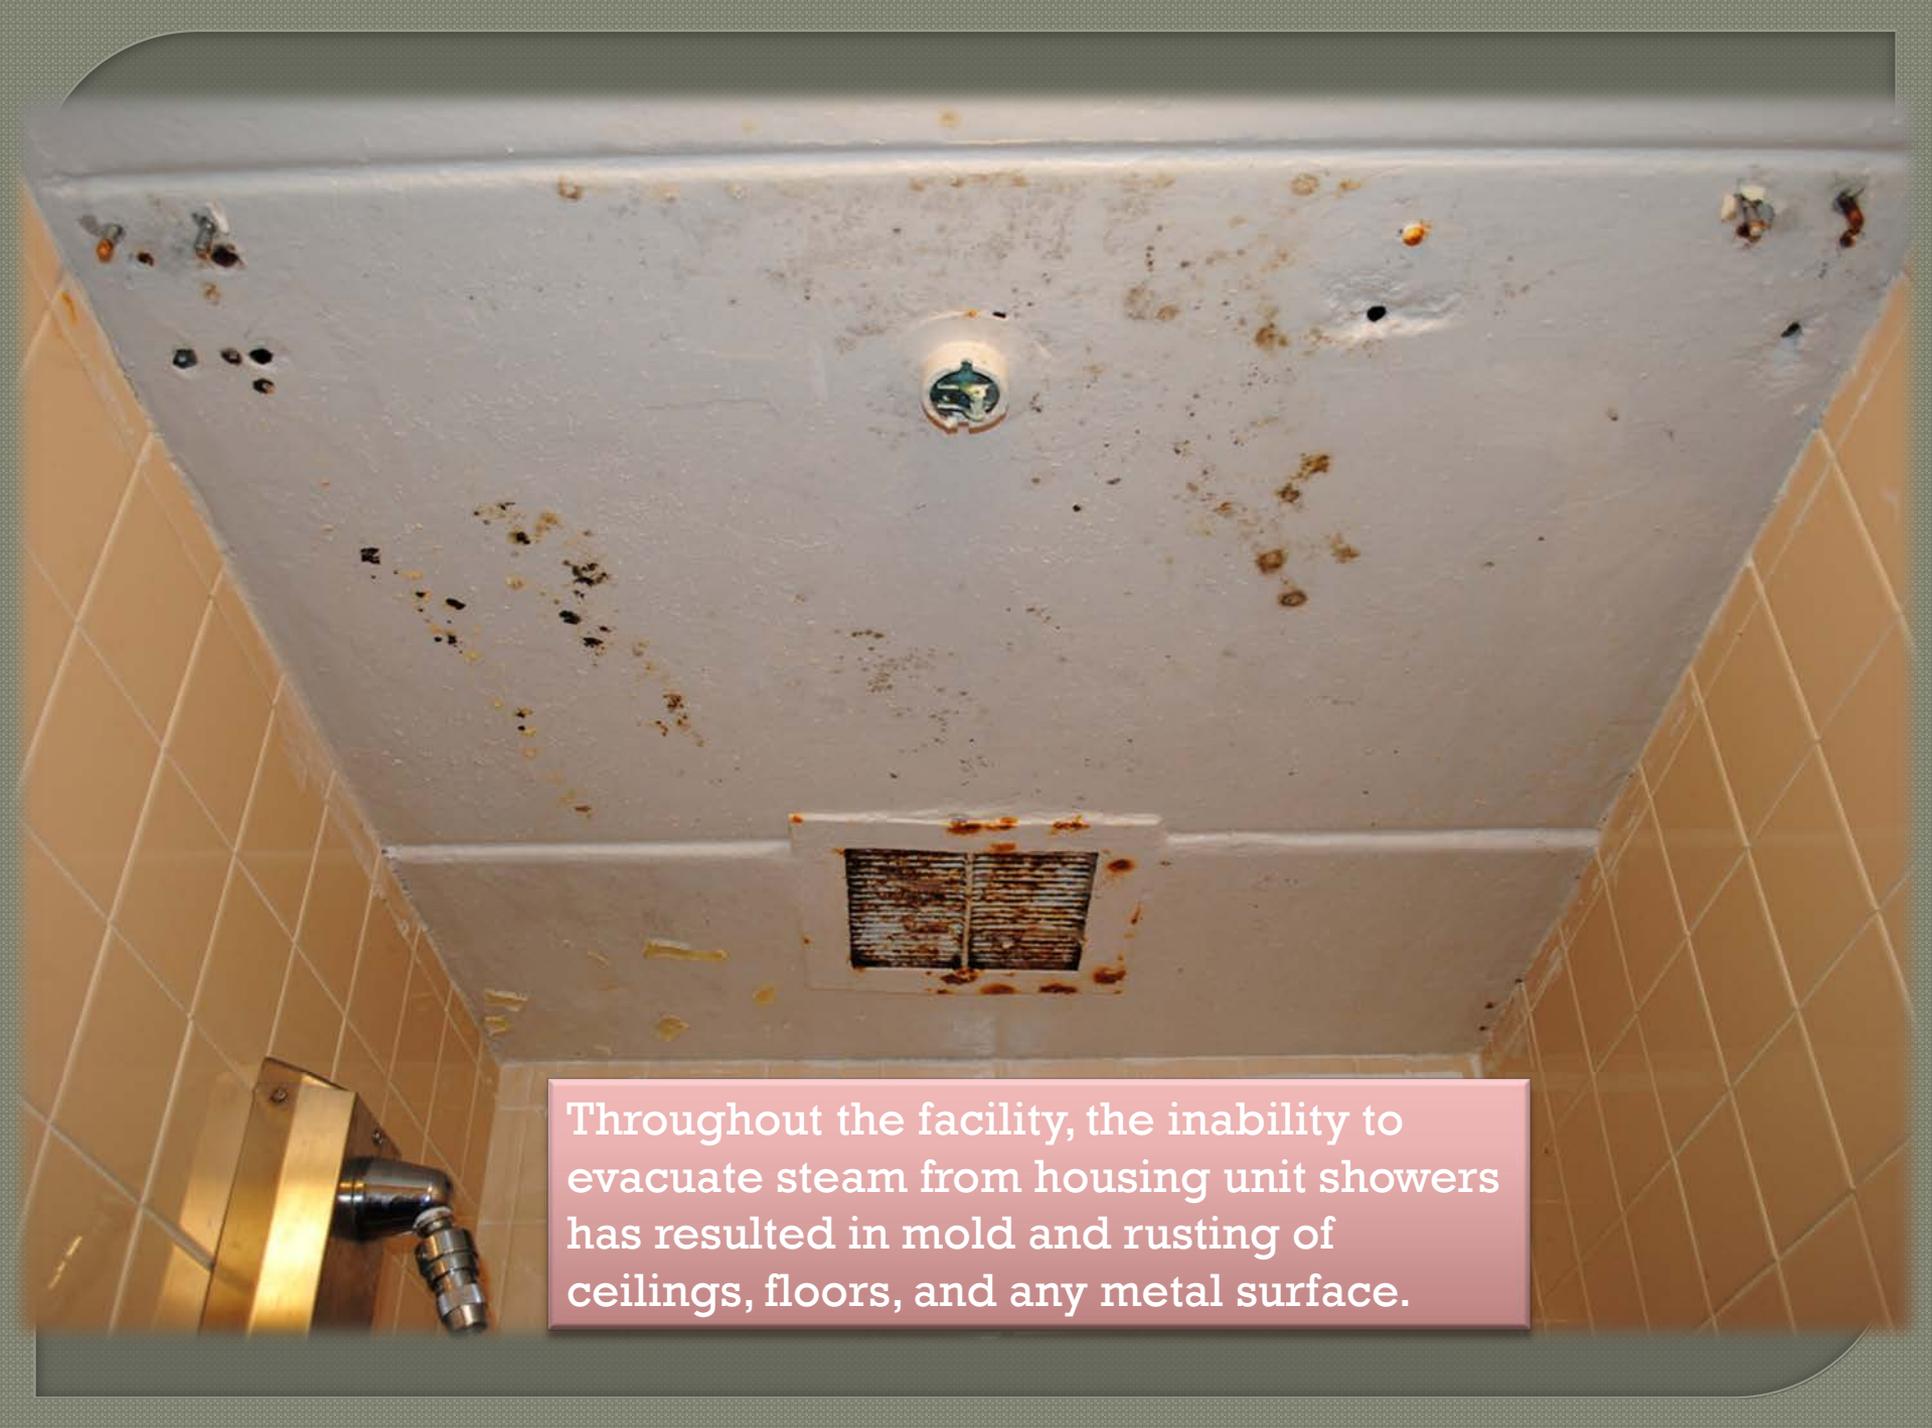
Throughout the facility, the inability to evacuate steam from housing unit showers has resulted in mold and rusting of ceilings, floors, and any metal surface.

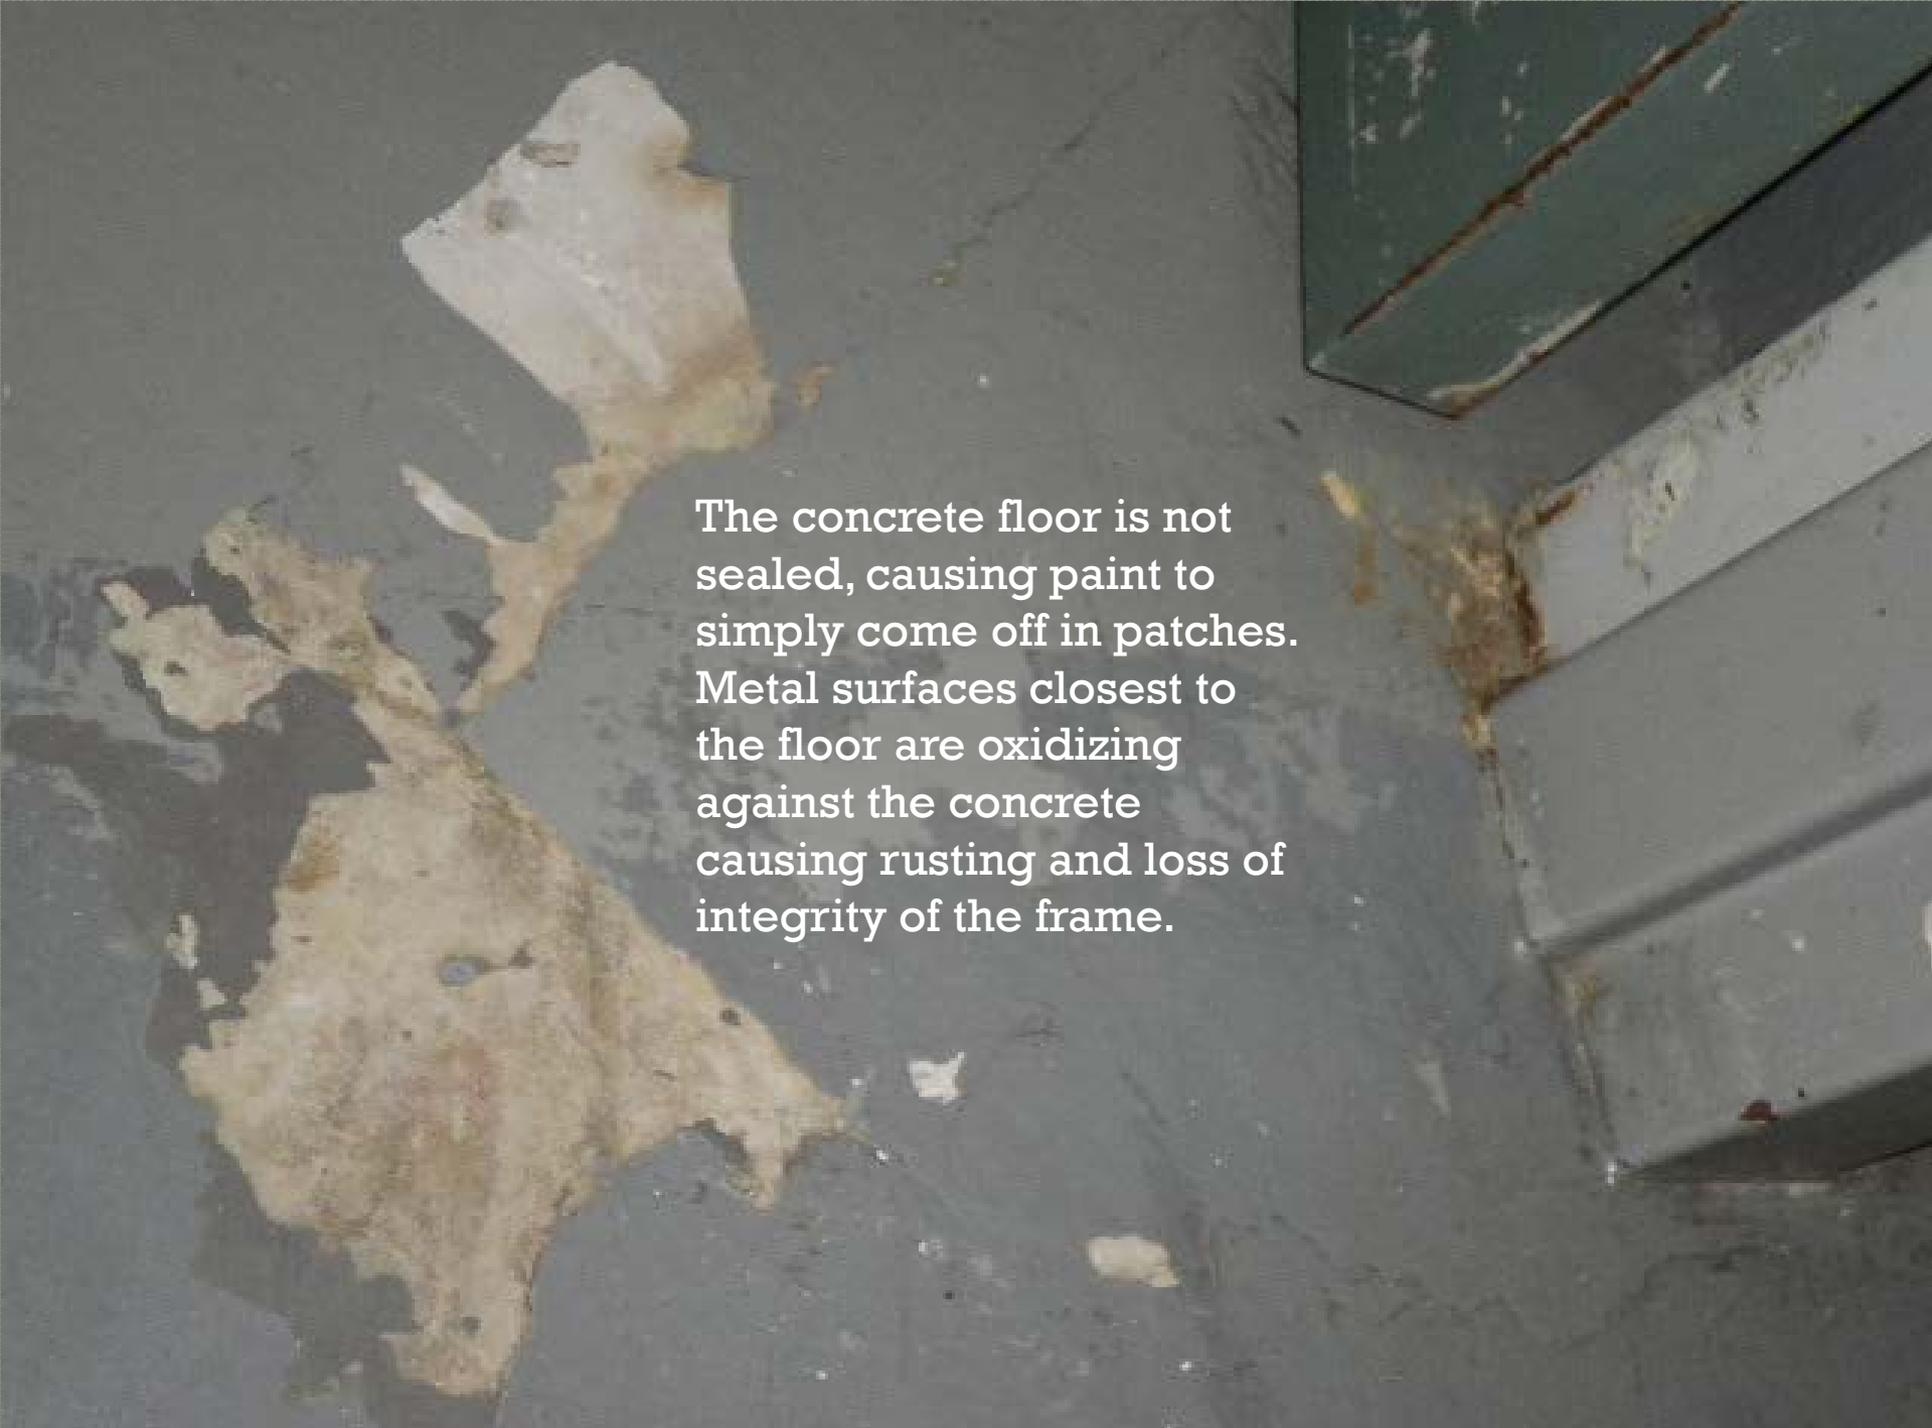
The concrete floor is not sealed, causing paint to simply come off in patches. Metal surfaces closest to the floor are oxidizing against the concrete causing rusting and loss of integrity of the frame.

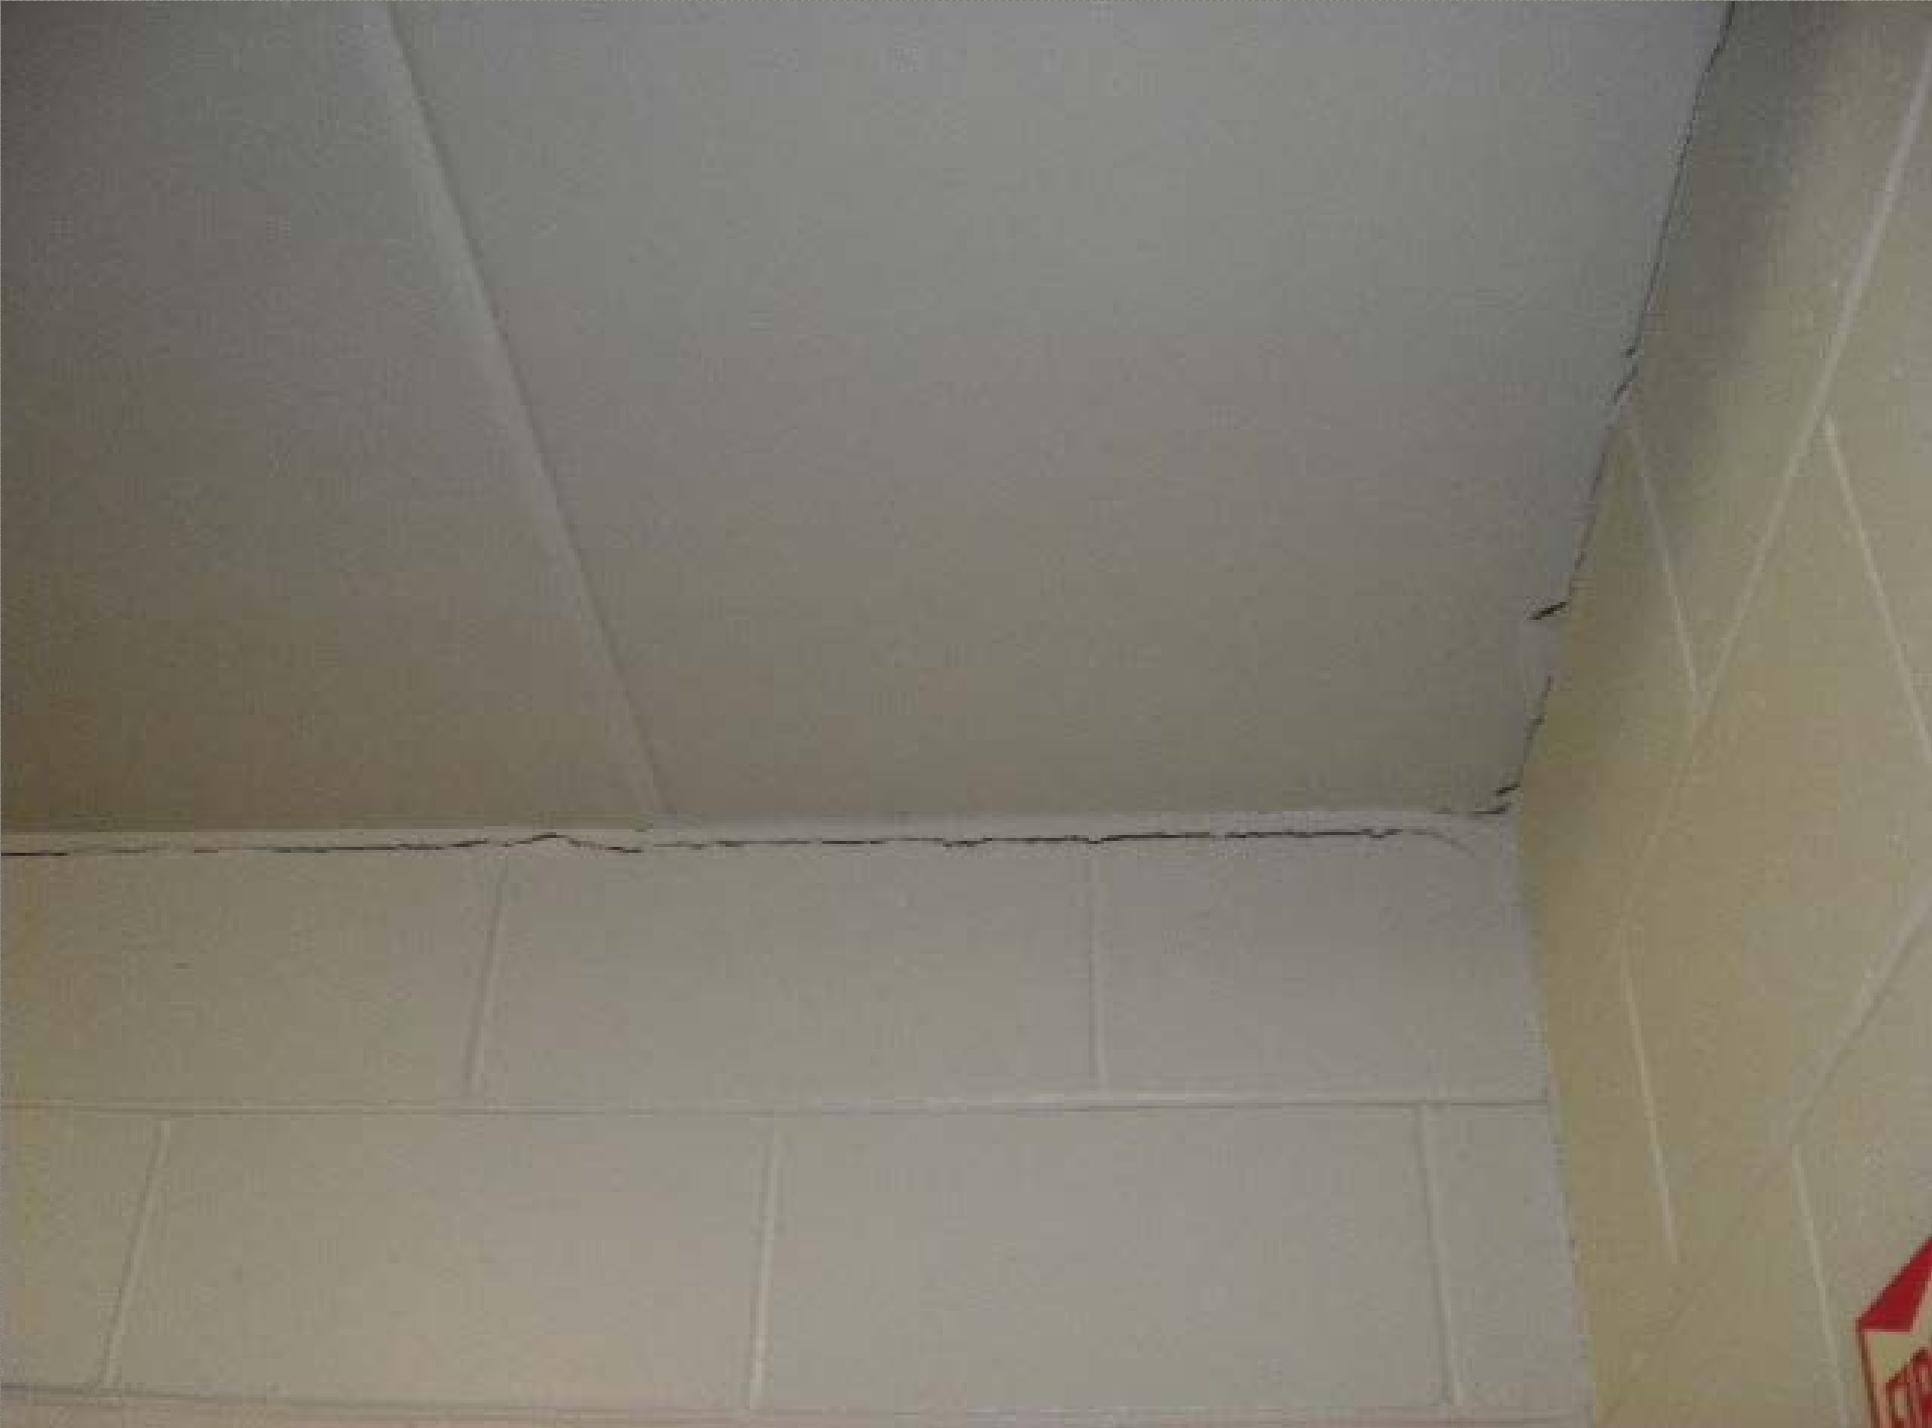
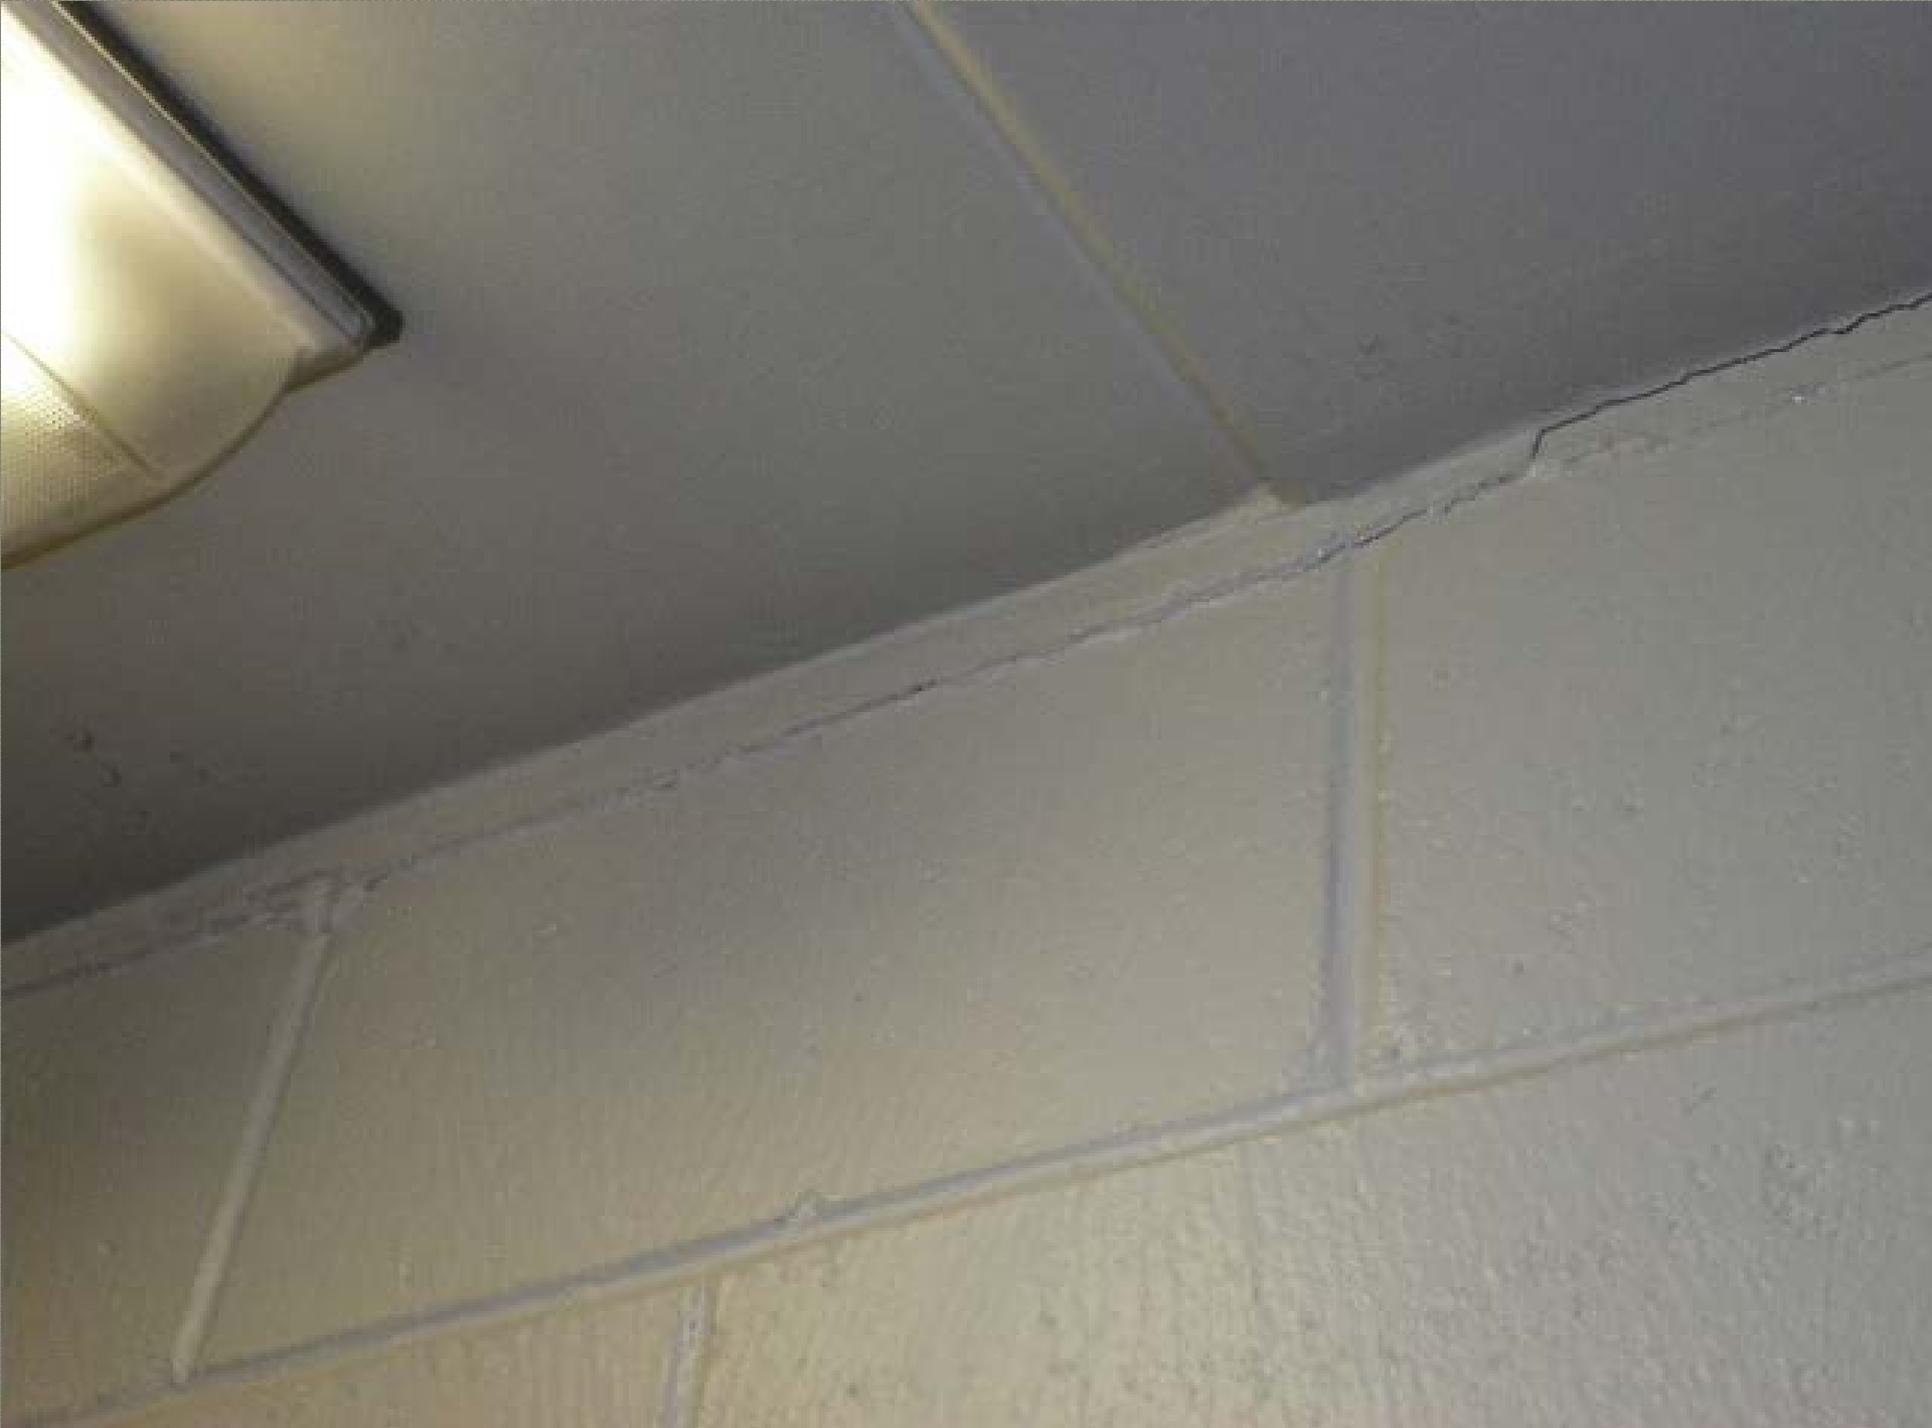
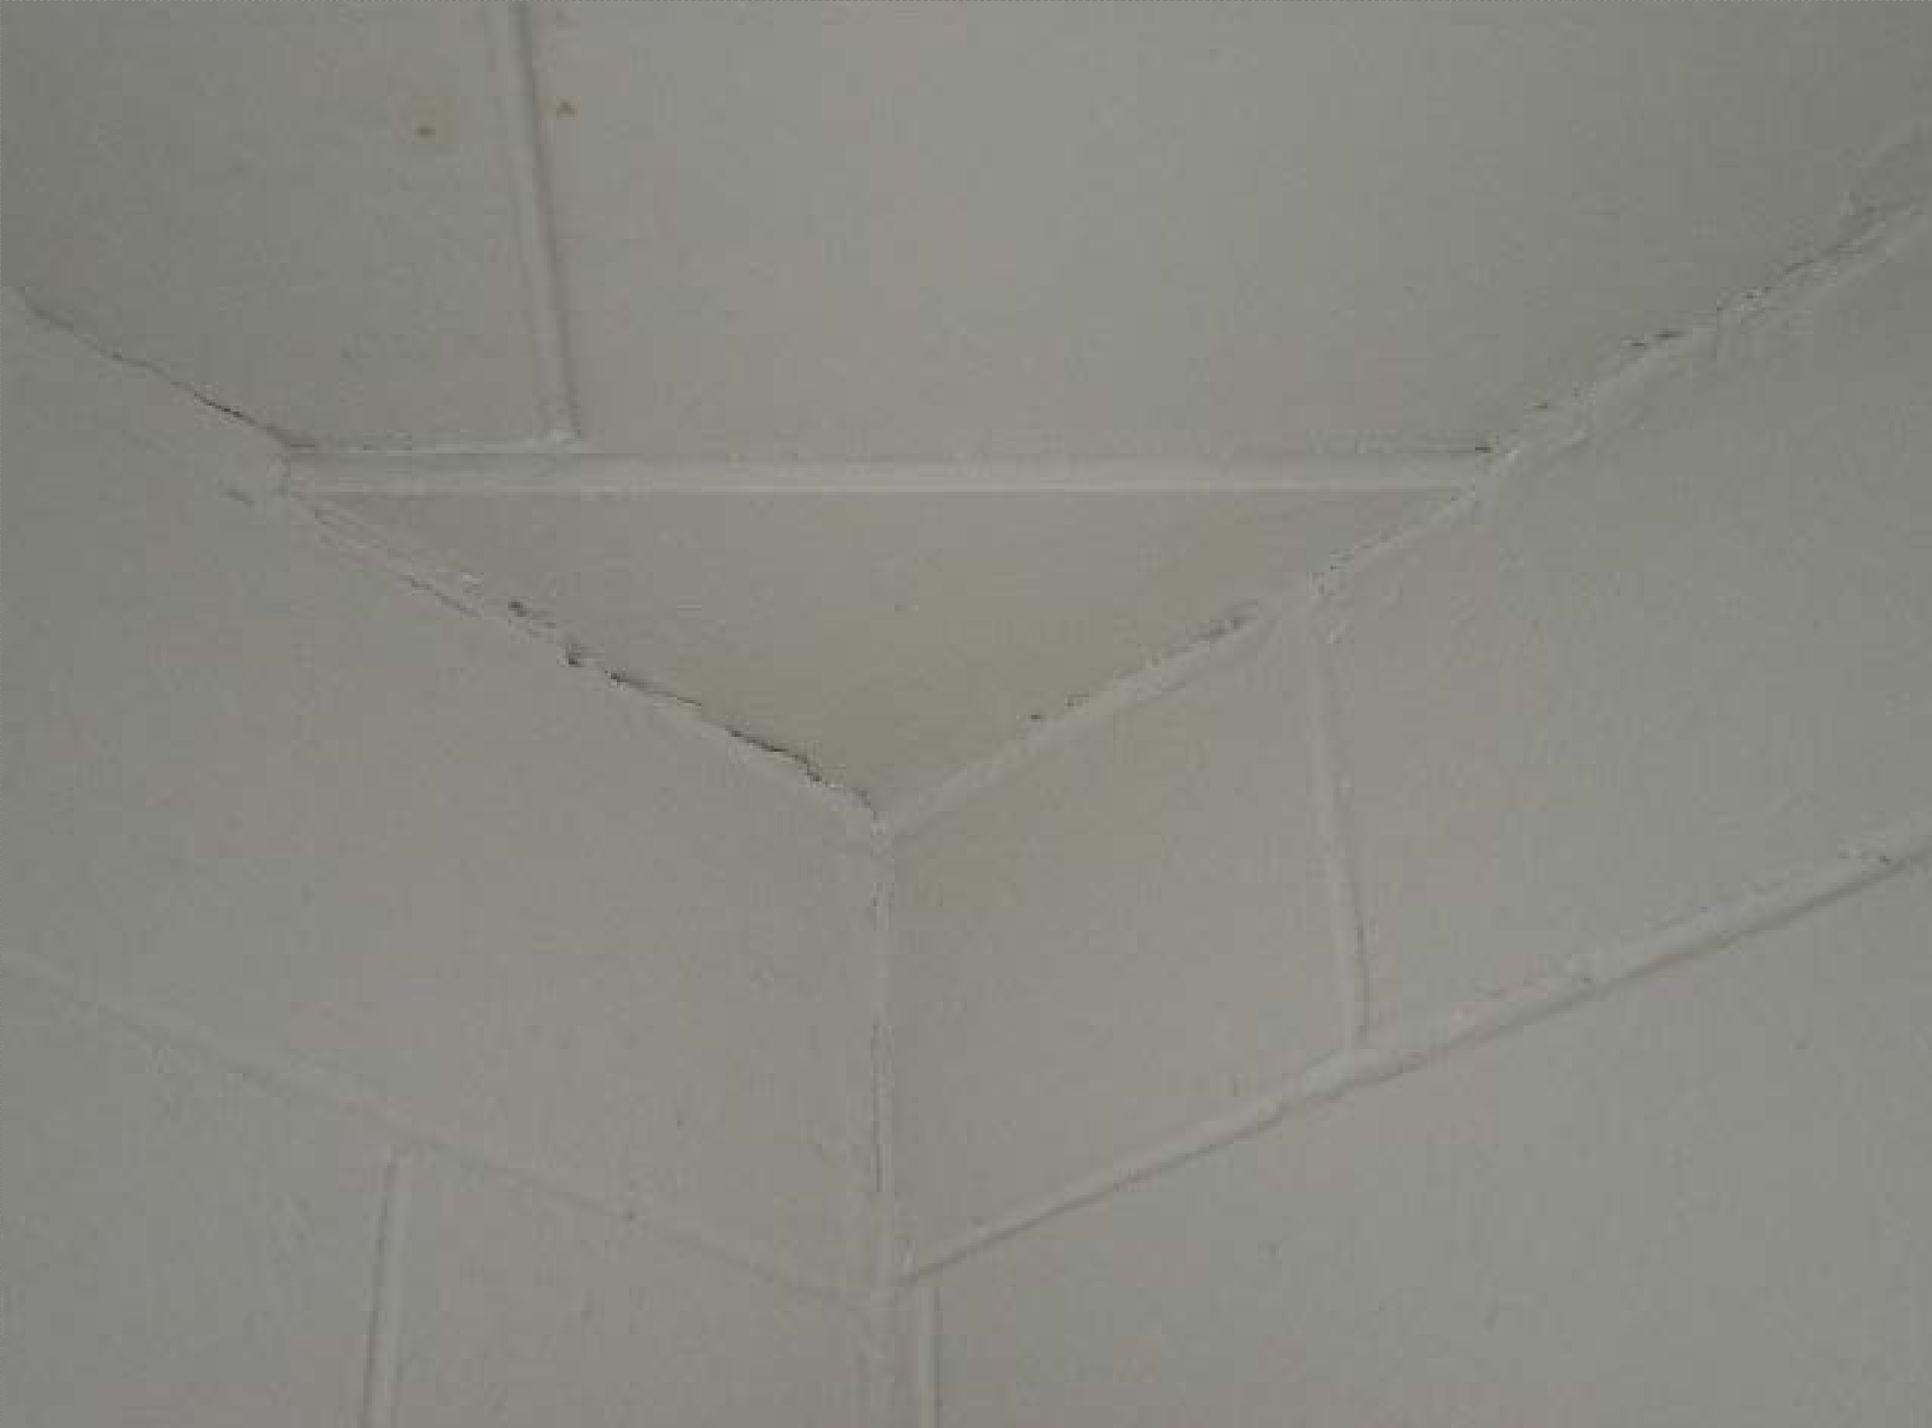
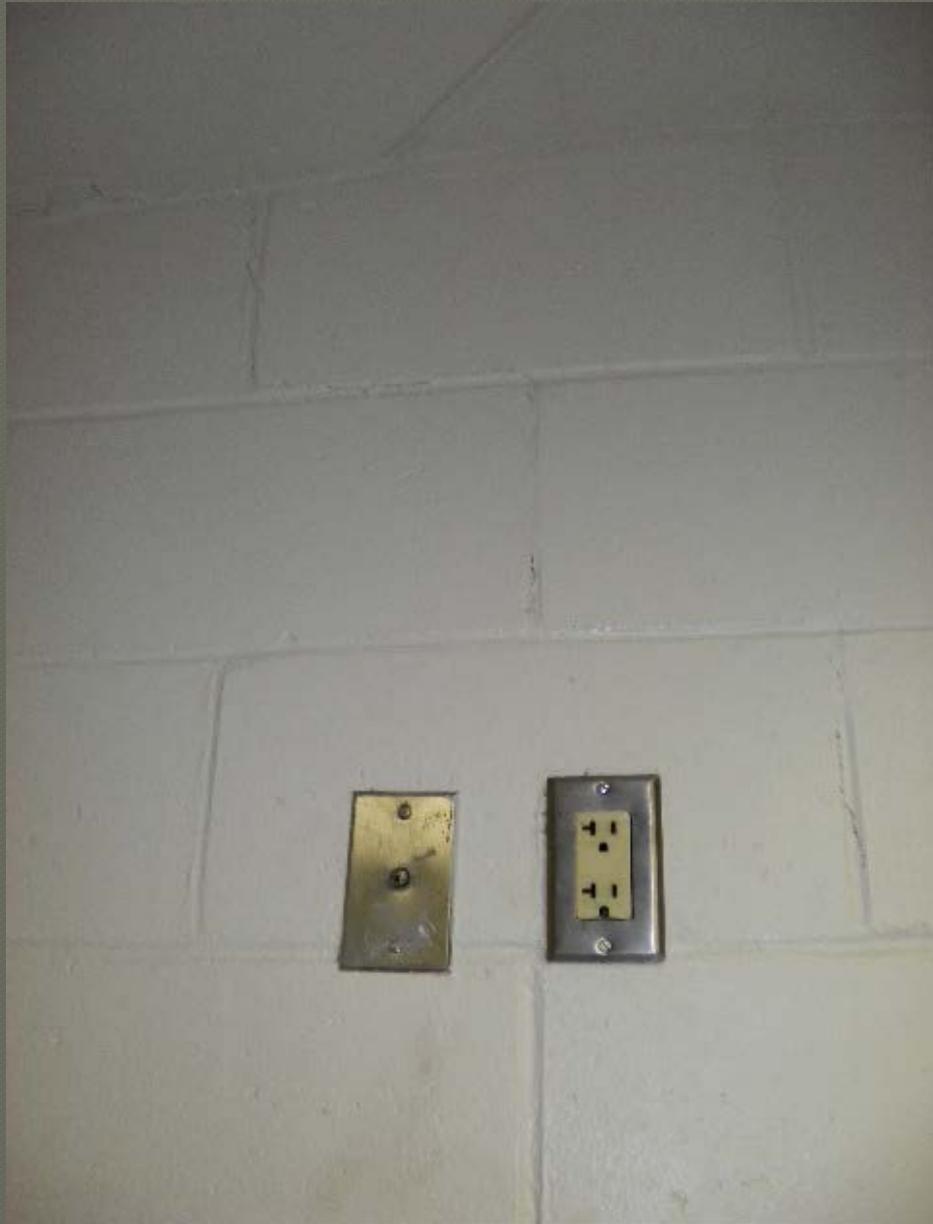
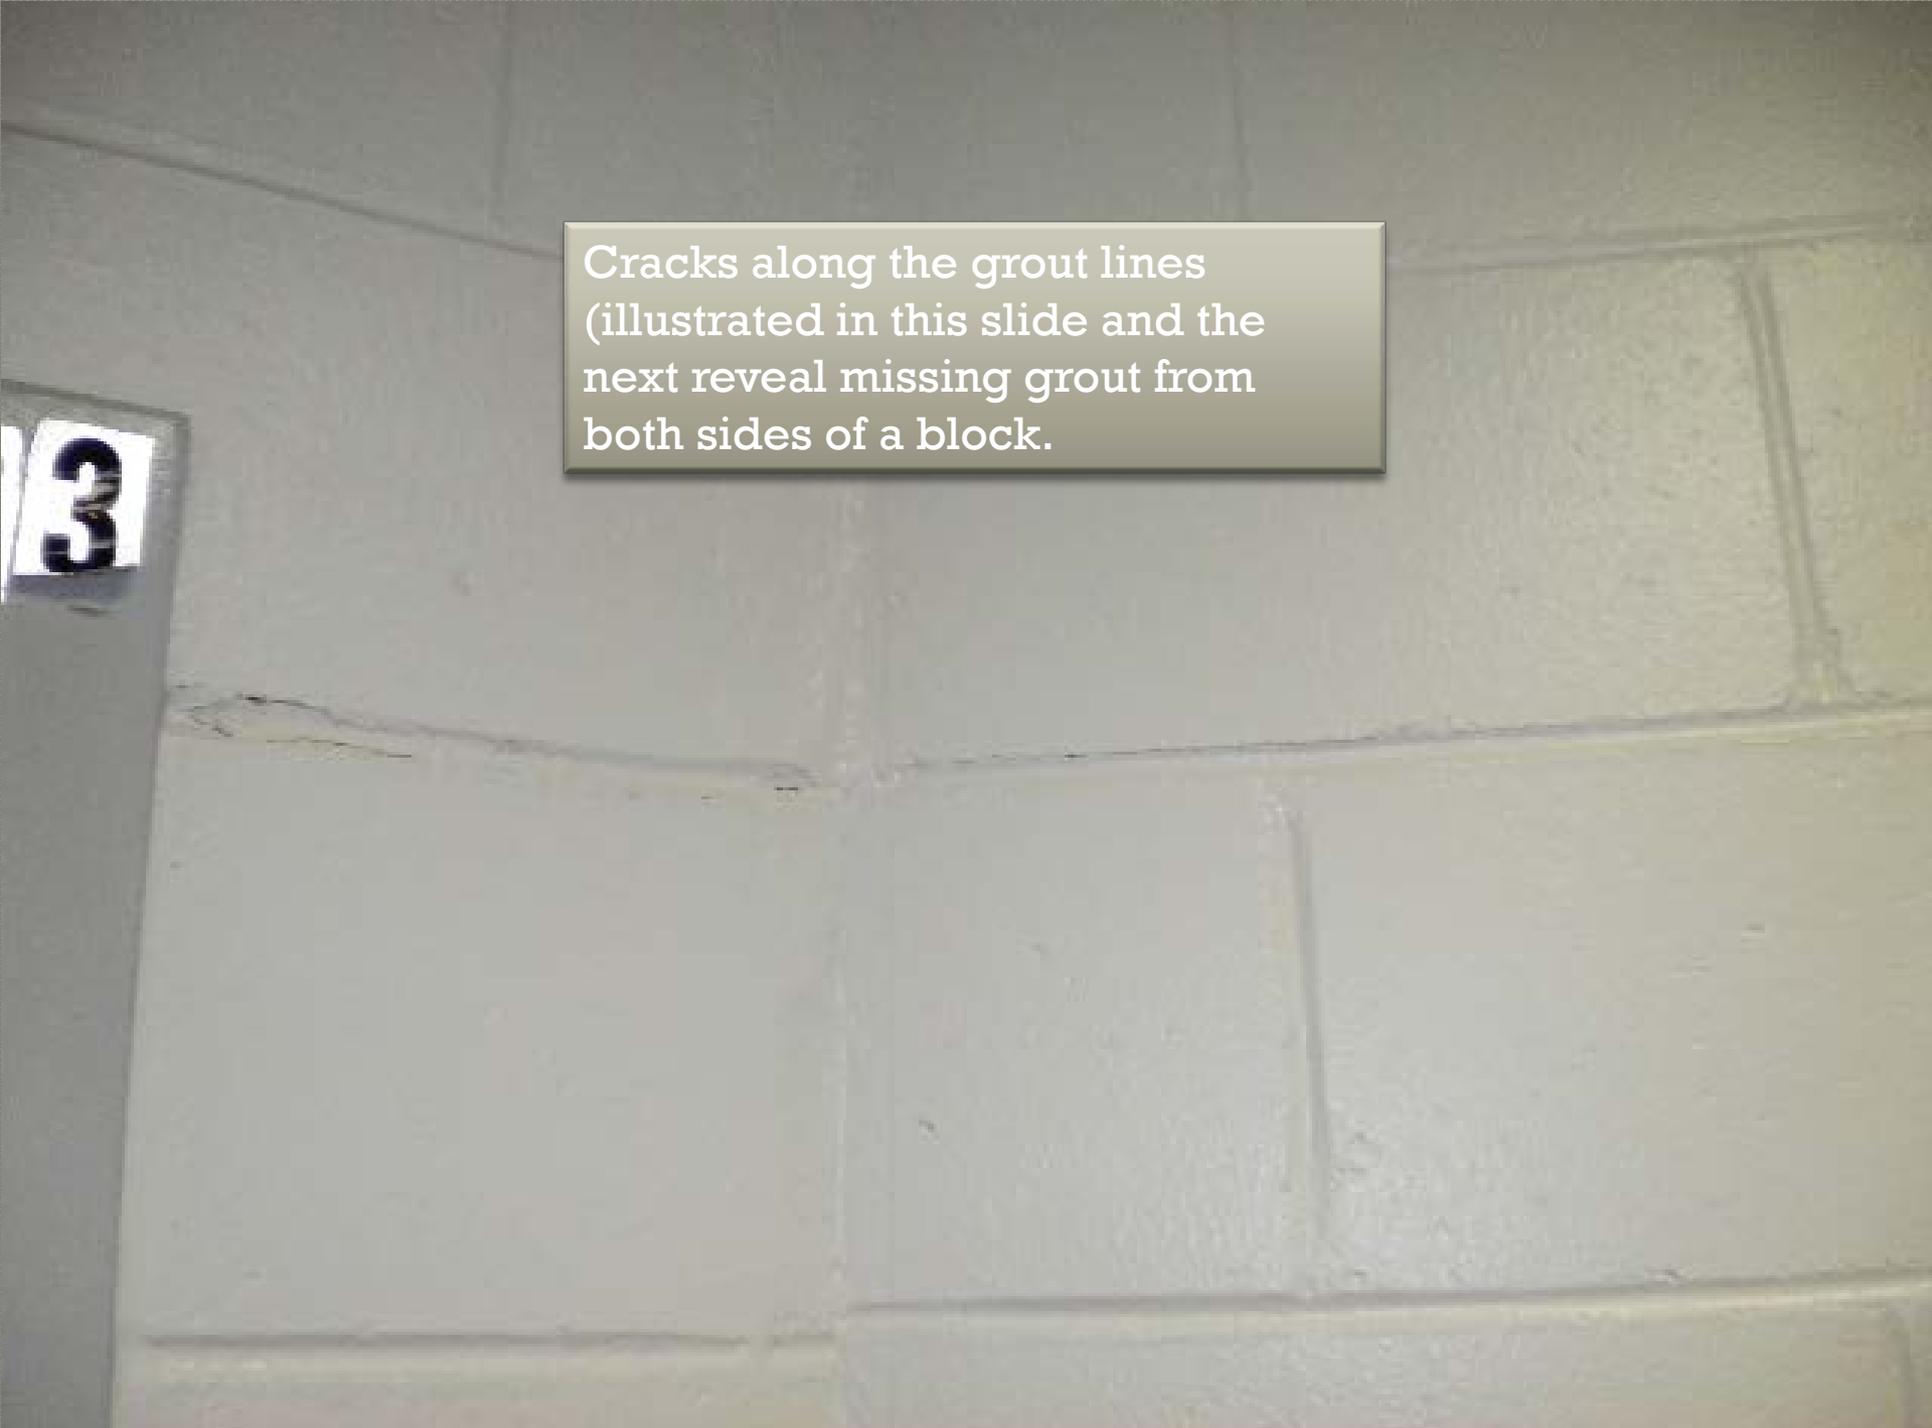
Cracks along the grout lines
(illustrated in this slide and the
next reveal missing grout from
both sides of a block.

In many of these areas where grout is already weakened, the grout can be removed and the whole block can be moved, and contraband hidden – Toothpaste covers the hidden items and appears to be “normal”!

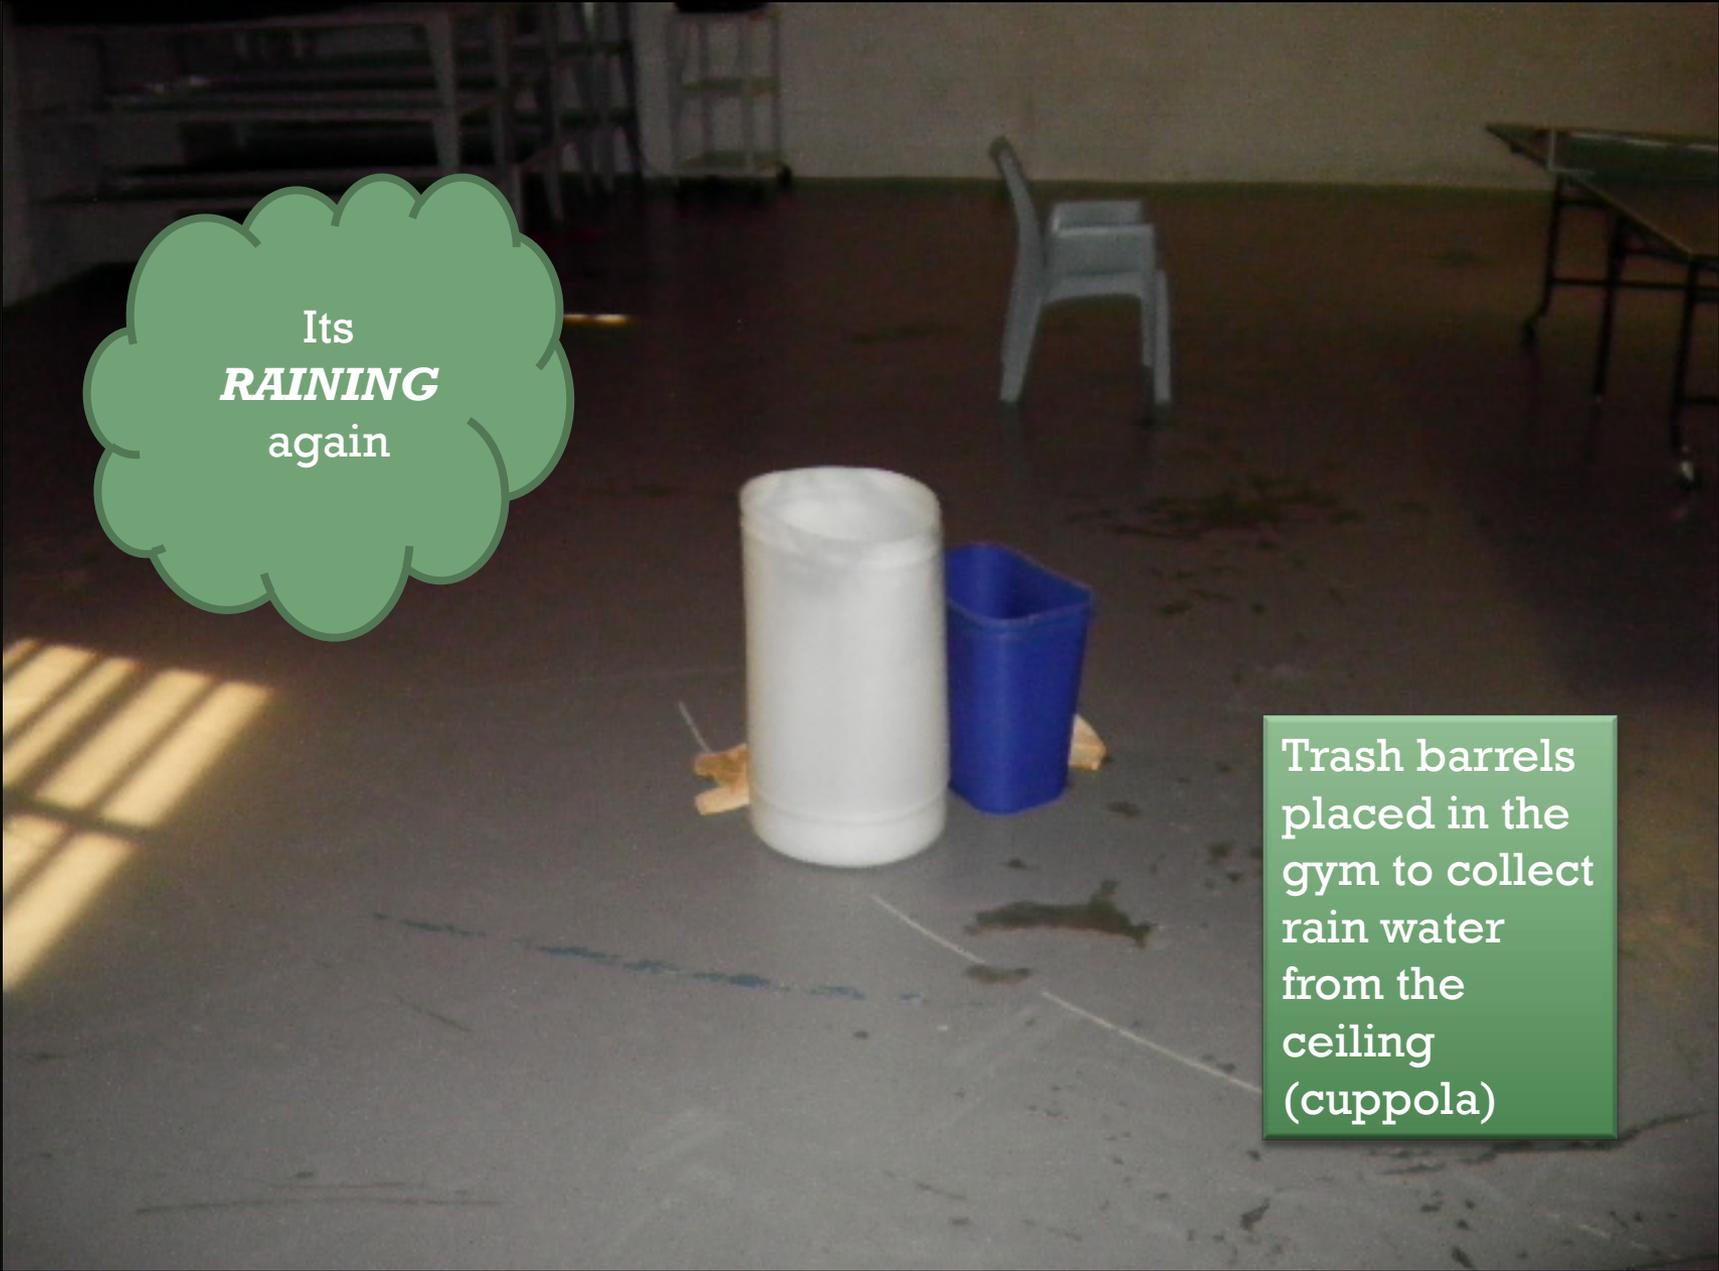
Its
RAINING
again

Trash barrels
placed in the
gym to collect
rain water
from the
ceiling
(cuppola)

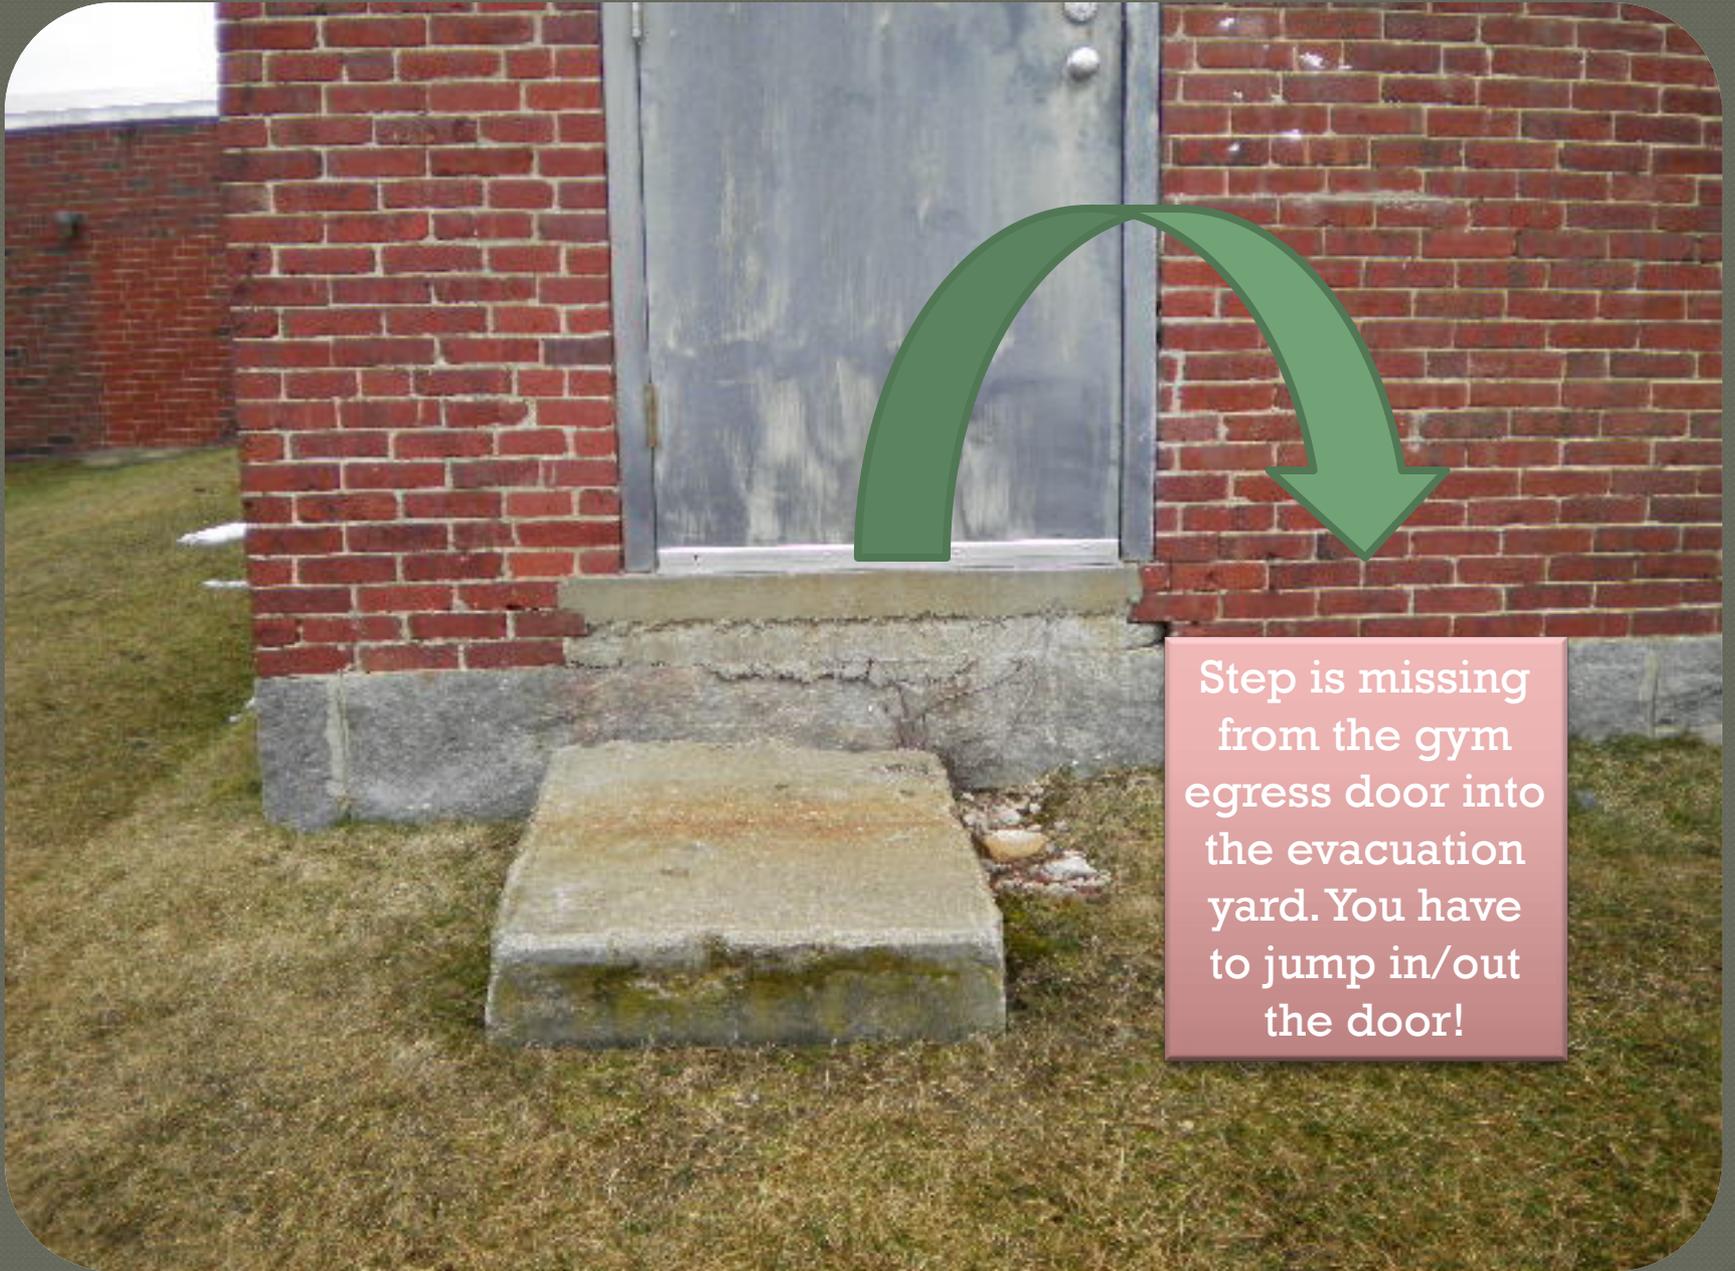
Step is missing from the gym egress door into the evacuation yard. You have to jump in/out the door!
