Deficiencies in the Existing Belknap County Jail and House of Corrections Facility

By Daniel P. Ward Sr.,
Superintendent

March 28, 2013

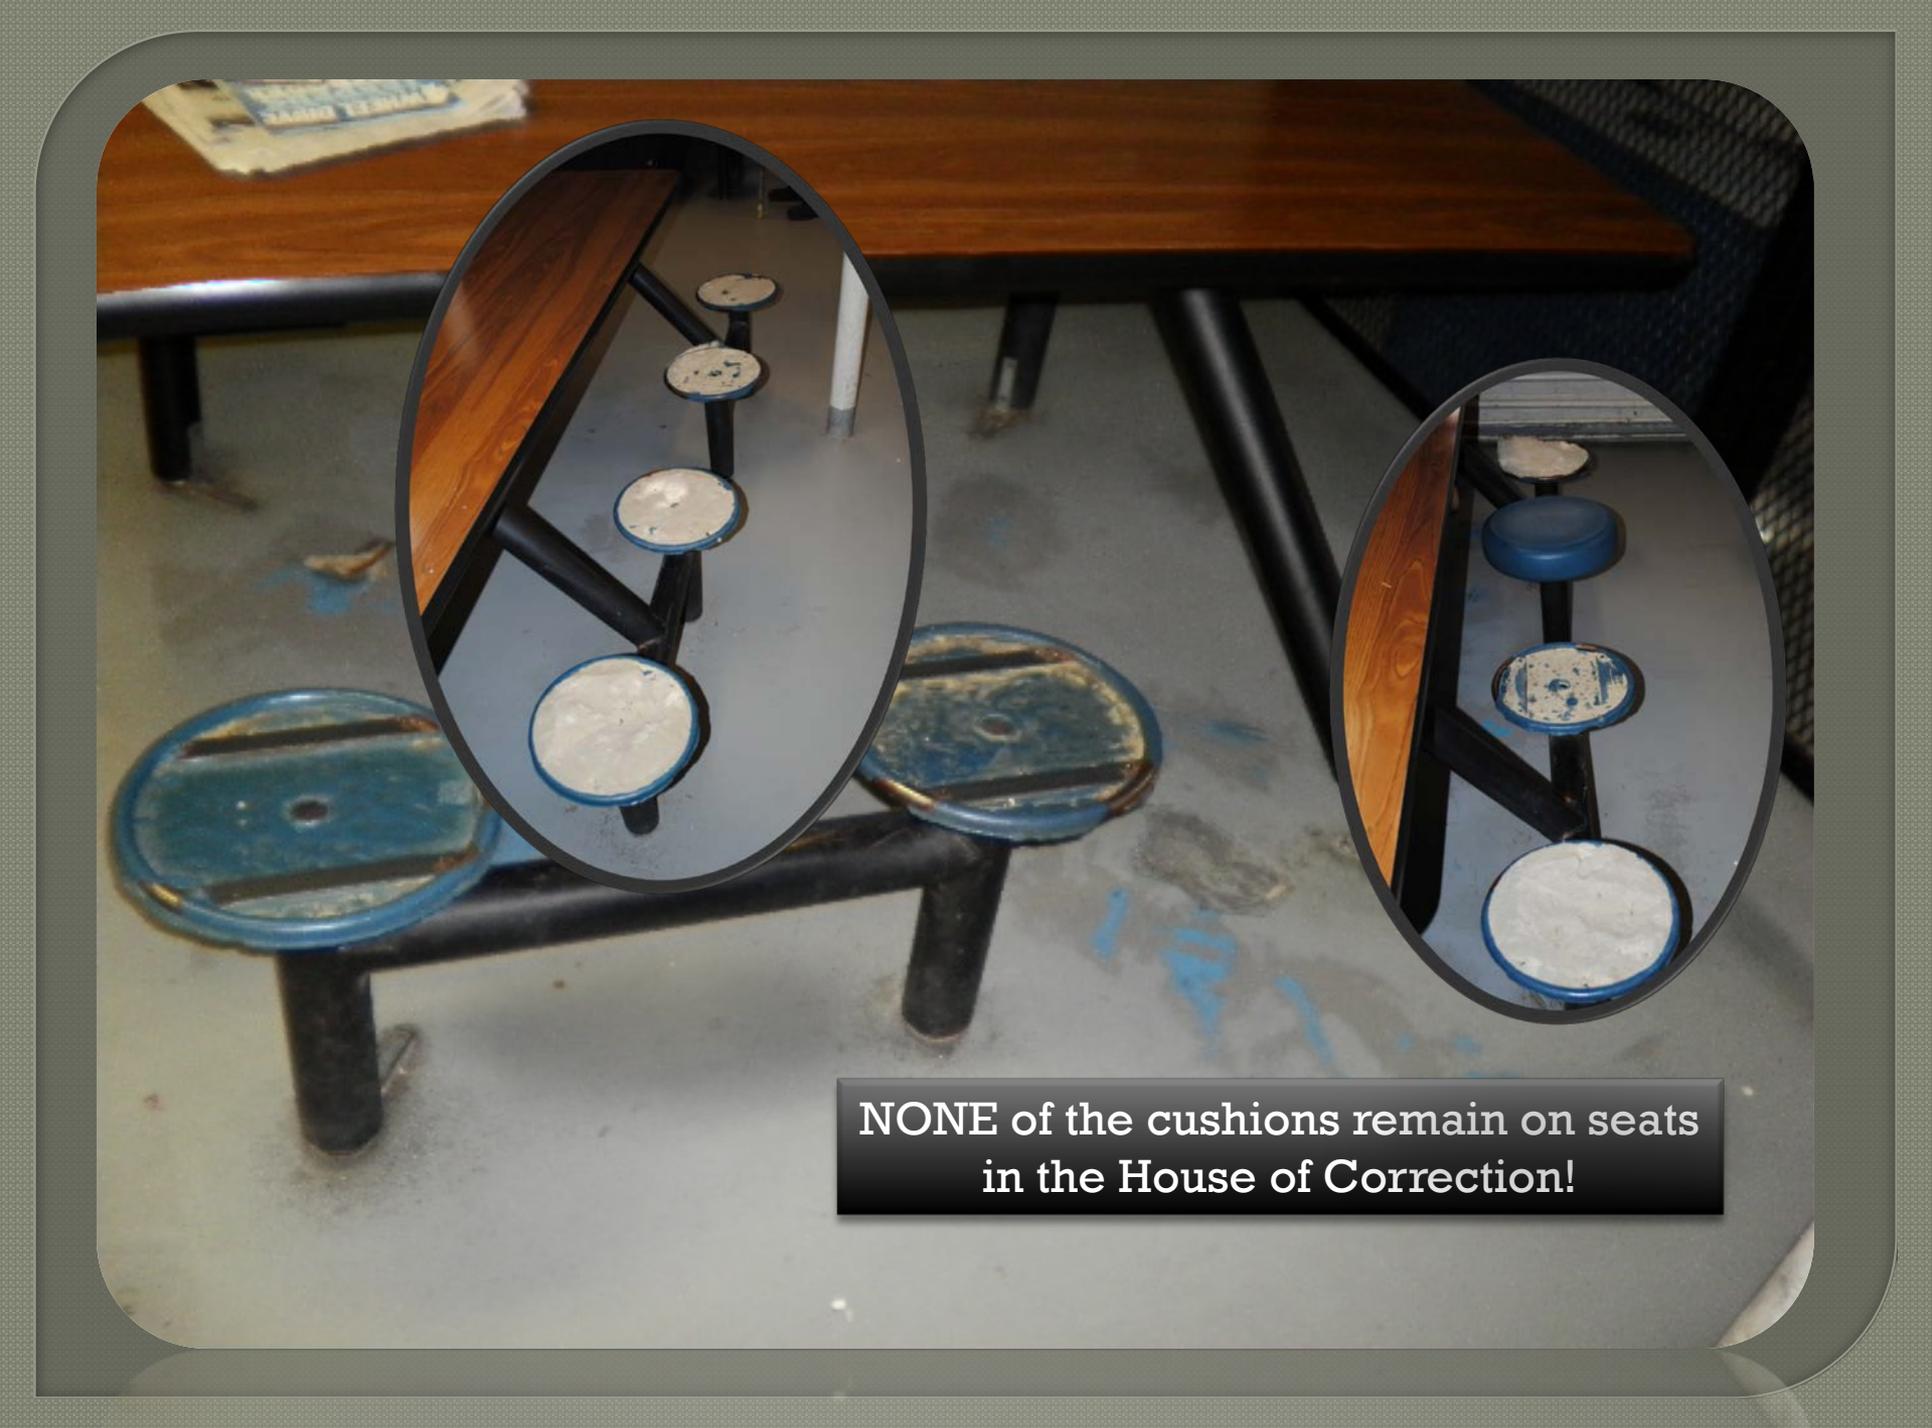
NONE of the cushions remain on seats
in the House of Correction!

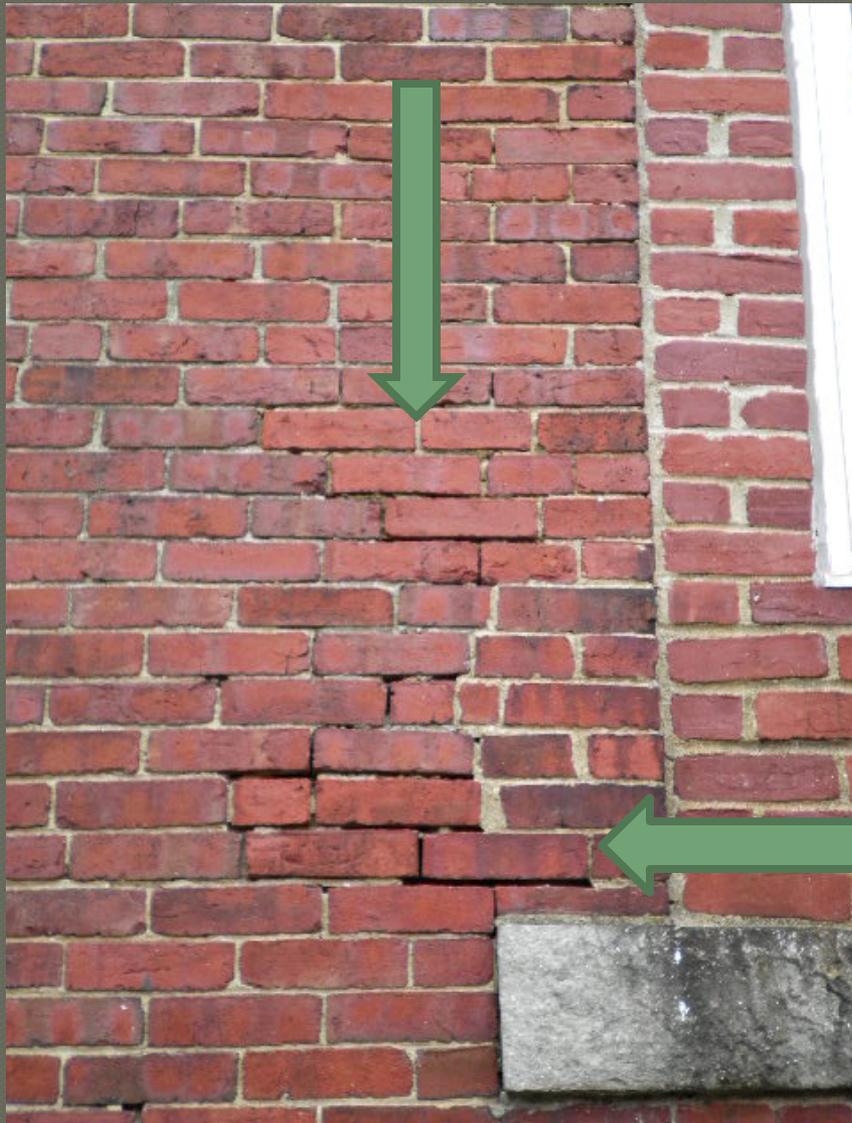
The 1890's section of the building is losing mortar from the bricks. As a result, bricks are slipping and falling out and weakening the adjacent bricks as water and ice continue to split the blocks.
